**Application for the Maritime Administration’s Port Infrastructure Development Program (PIDP)
Under the Infrastructure Investment and Jobs Act (“Bipartisan Infrastructure Law”)**

**Matagorda County Navigation District #1 dba the Port of Palacios
Energy & Resilience Improvement Project (ERIP)
Matagorda County, Texas**

PROJECT NARRATIVE

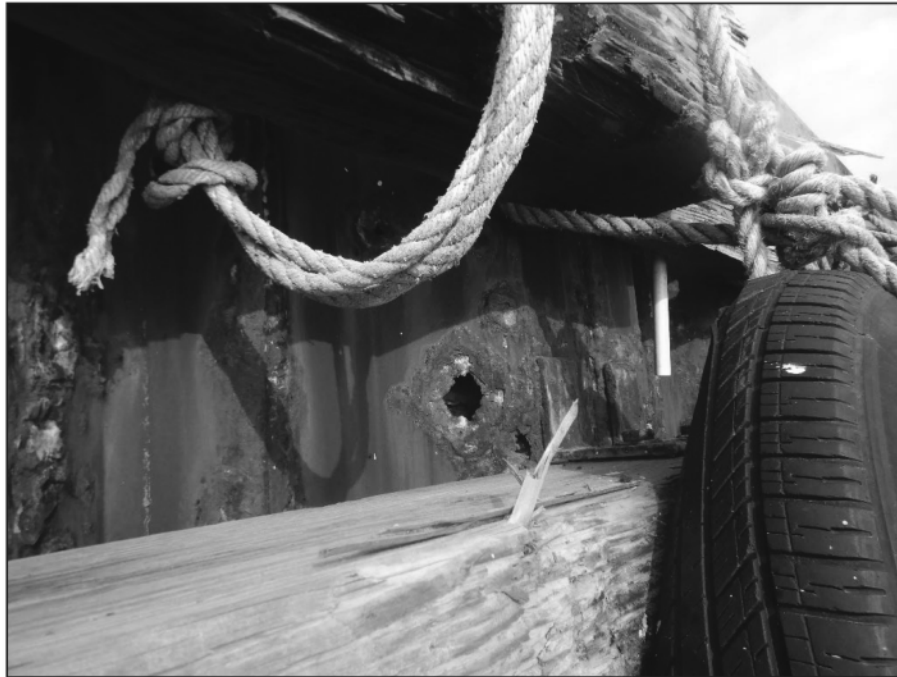
The 1980s steel sheet pile bulkheads are in overall **Poor Condition**, with up to 100% coating loss, moderate pitting, up to 1" scale throughout above water portions, with localized areas of thru holes in the sheeting (see Photo 2-1). Below water, the coating was observed to be intact with no notable deficiencies (see Photo 2-2). Specific locations, deficiencies, and photograph reference are identified in Table 2-1 below. Refer to Appendix B for ultrasonic thickness readings.

Photo 2-1 – Typical Above Water Condition of 1980s Steel with Localized Thru Hole (Sta 113+00 Shown)

- The 1980s steel sheet pile bulkheads are approaching the end of their useful service life in their current state. It is recommended that a comprehensive repair/rehabilitation program be undertaken within approximately the next 5 years to reduce the likelihood that the advanced deterioration in the splash zone will impact the overall performance of the bulkhead. Several corrosion holes were observed within the splash zone and the tie-back assemblies are severely deteriorated along widespread portions of the site. Continued deterioration in these areas can lead to failure of the wall due to failure of the sheet piles and/or tie-back assemblies, which can lead to horizontal movement of the wall and upland damage or serviceability restrictions. It is recommended that these bulkhead sections be rehabilitated by installing a concrete facing

extending from approximately 3' below MLW to the existing cap. This will require removal and replacement of the existing fendering systems to complete the work. Our rough order of magnitude conceptual cost estimate for this repair is approximately \$13.8M for 5,775 linear feet of bulkhead, or approximately \$2,400/ft.

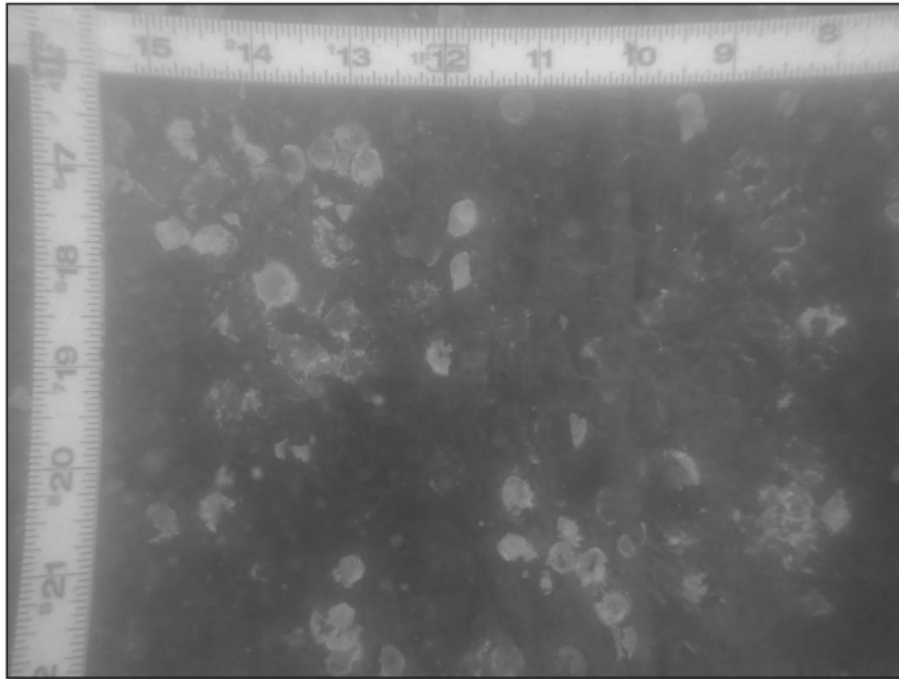
Photo 2-2 – Typical Underwater Condition of 1980s Steel (coating generally intact)

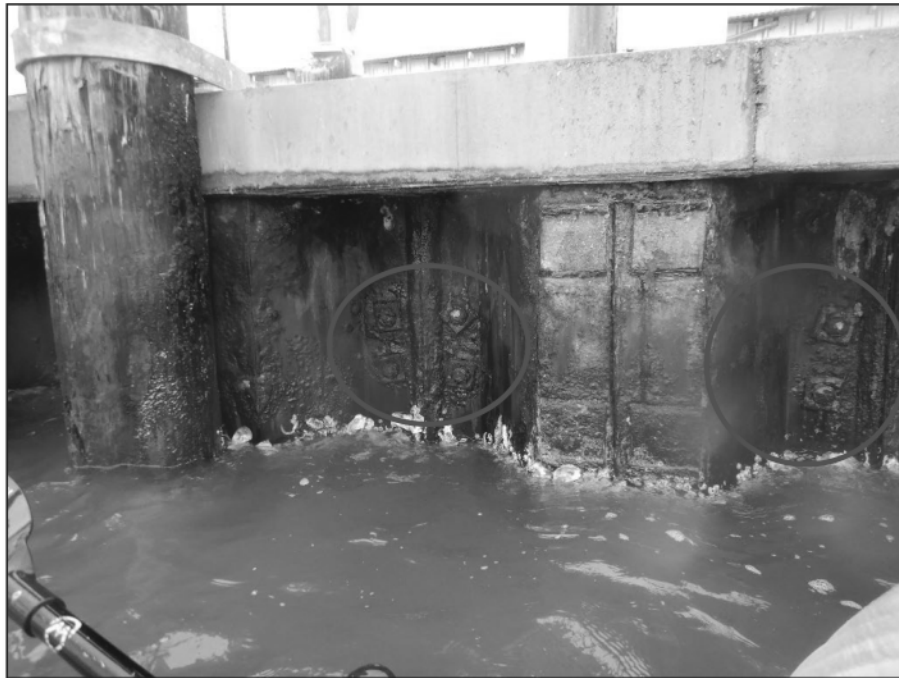
Photo 2-3 - Section Loss in Tieback Bolts and Washers between Sta 5+20-7+04

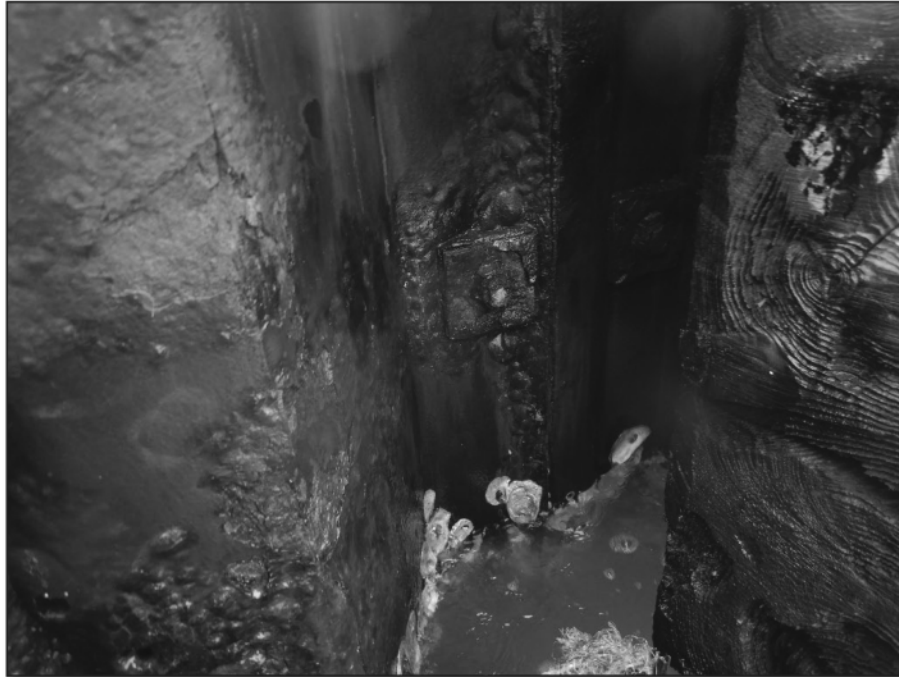
Photo 2-4 – Advanced Deterioration of Sheet Piles and Tie-Back Assembly (Sta 14+85)

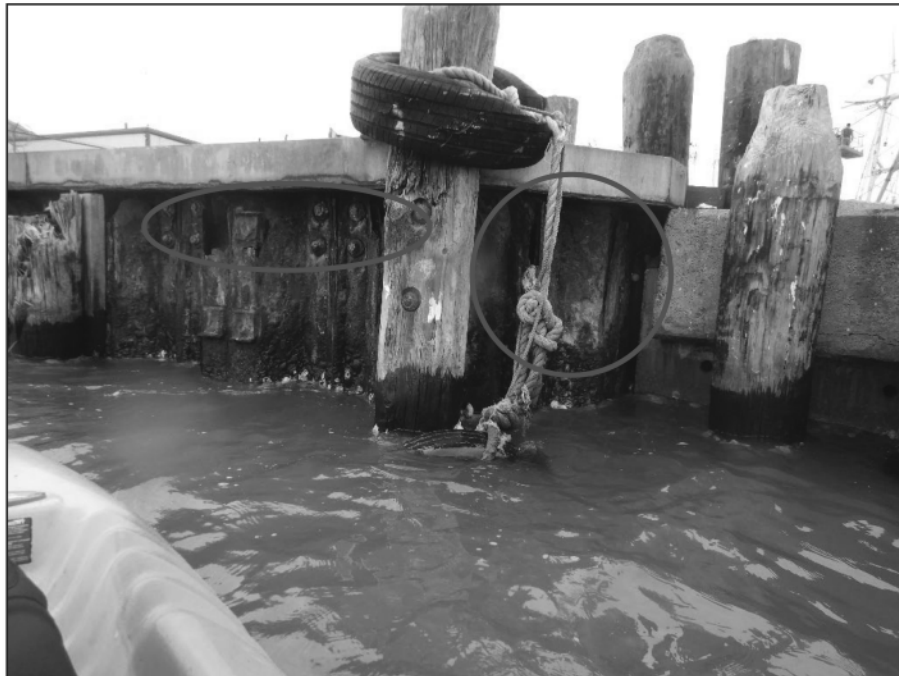
Photo 2-5 - Corrosion Holes at Transition (Sta 31+90)

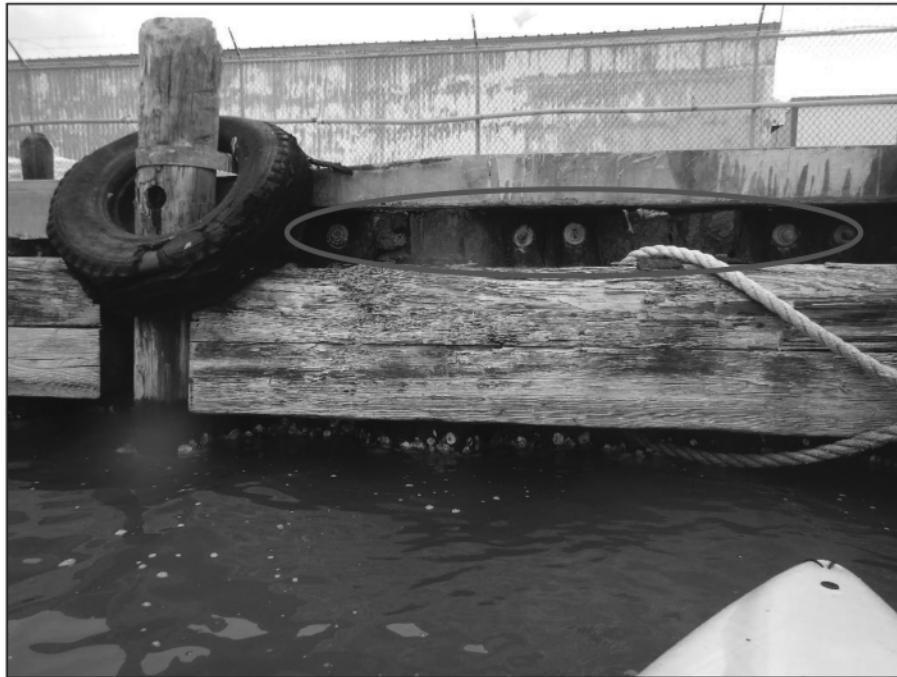
Photo 2-6 – Corrosion Holes at Top of Sheets (Sta 33+25)

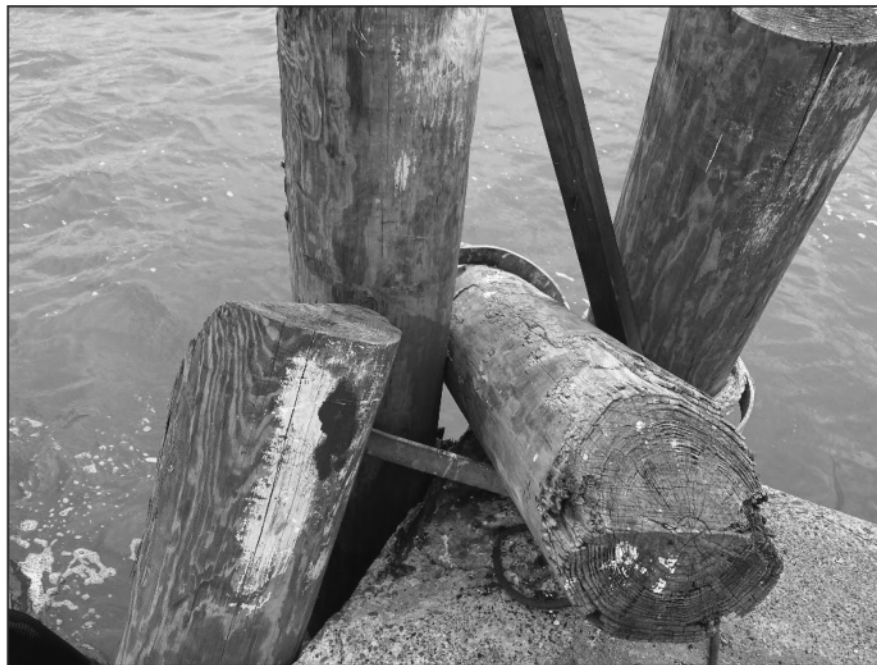
Photo 2-7 - Broken Fender Piles (Sta 31+83 Shown)

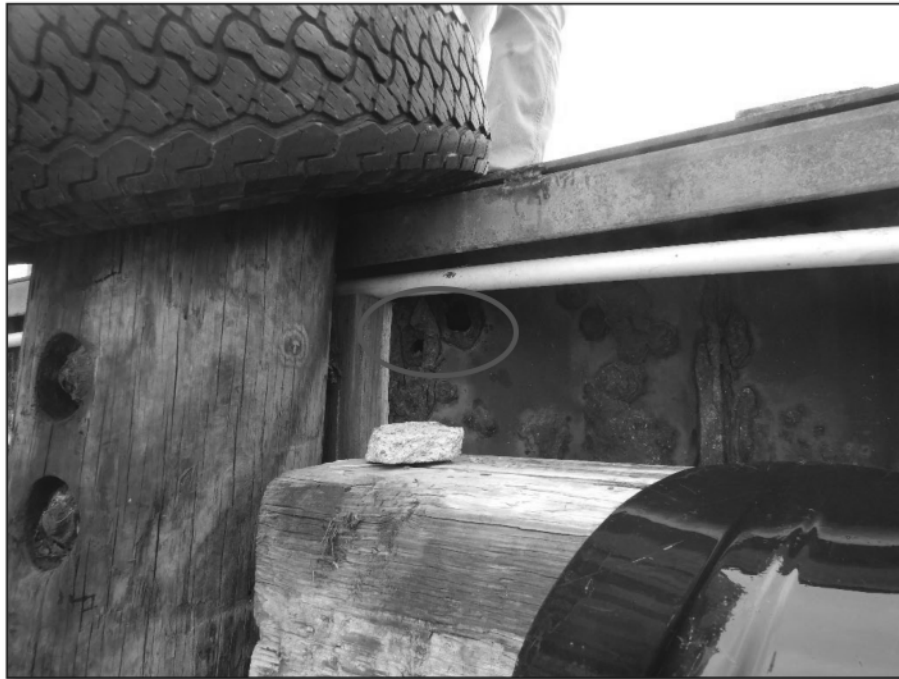
Photo 2-8 – Corrosion Holes in Sheeting at Sta 38+50

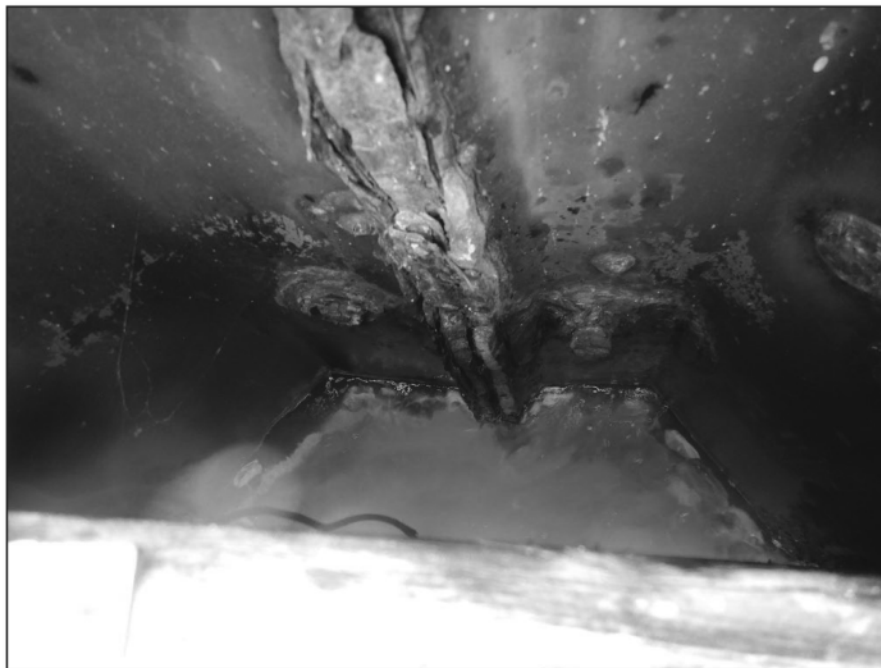
Photo 2-9 – ~100 % Section Loss in Tieback Assembly (Sta 32+00-39+50)

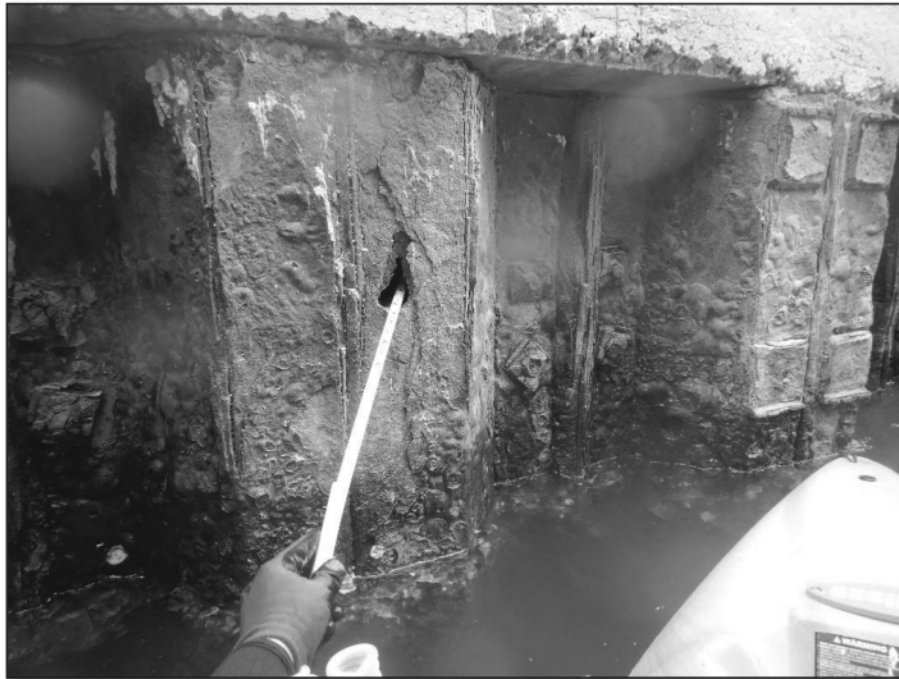
Photo 2-10 – Corrosion Holes in Sheet piling (Sta 40+00-40+50)

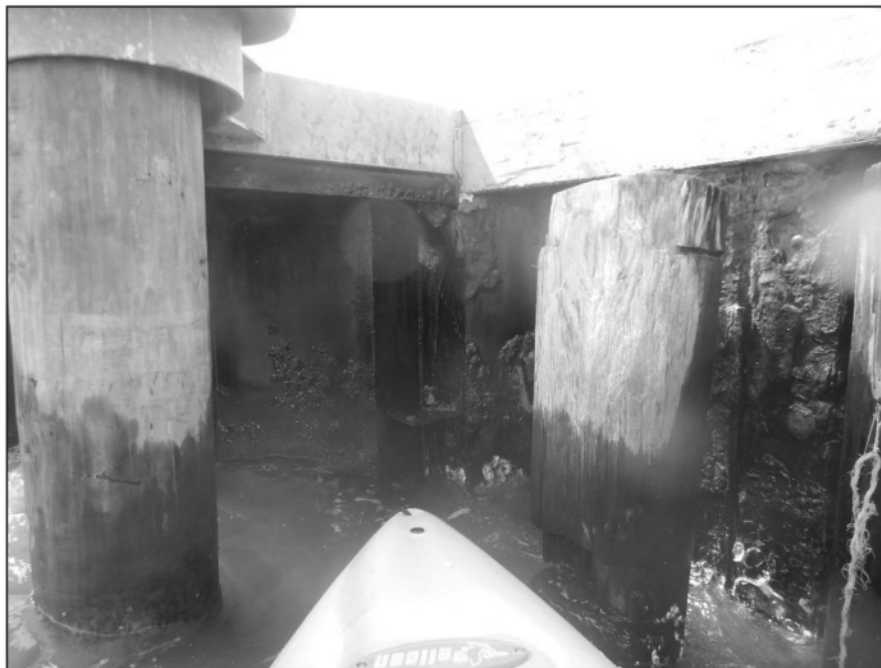
Photo 2-11 – Corrosion Hole at Transition (Sta 55+41), Concrete Fill Visible

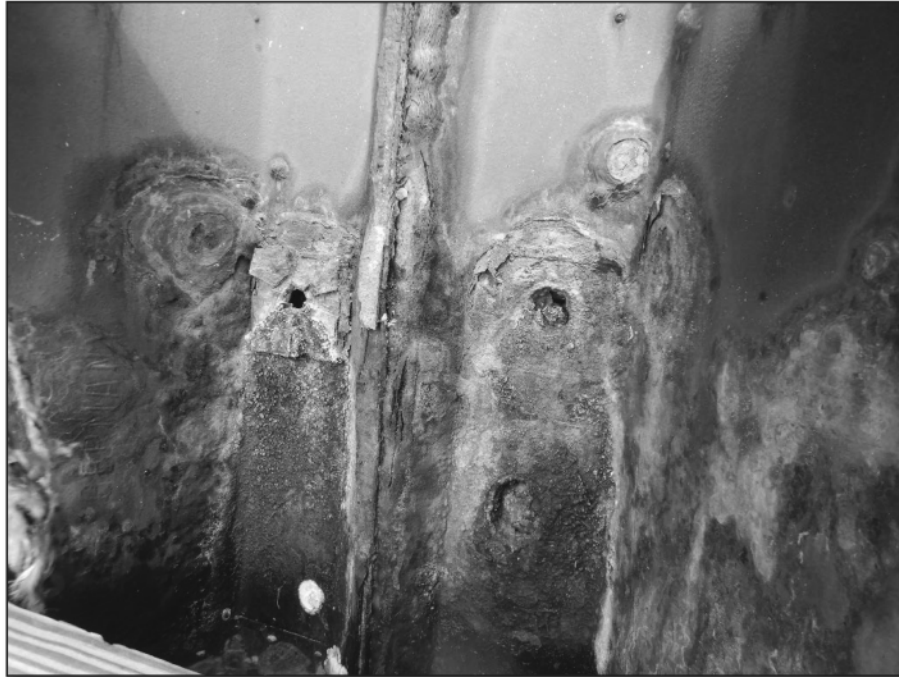
Photo 2-12 – ~100 % Loss in Tieback Assembly with Active Fill Loss (62+85-63+75)

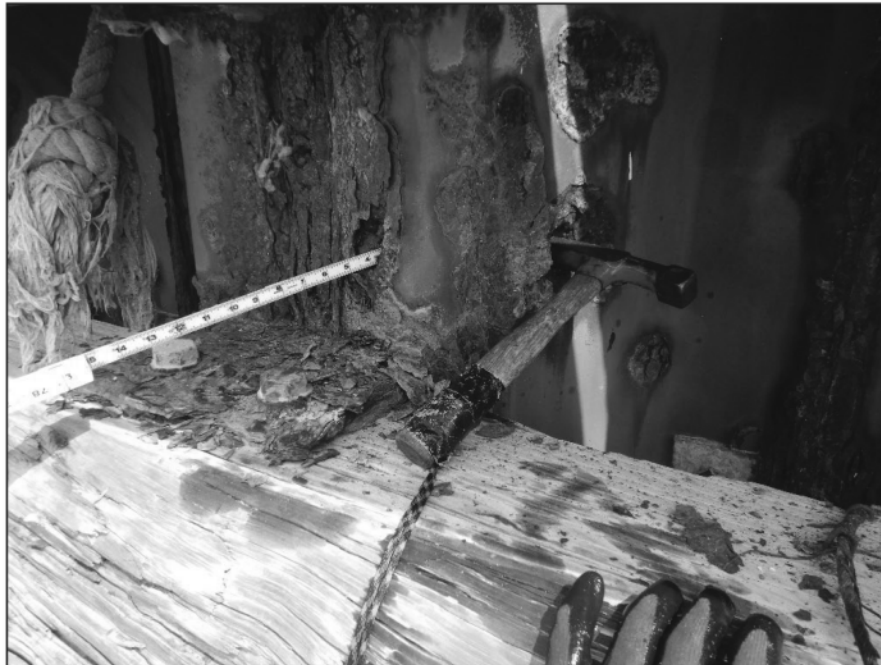
Photo 2-13 – Corrosion Holes in Sheeting (Sta 65+75)

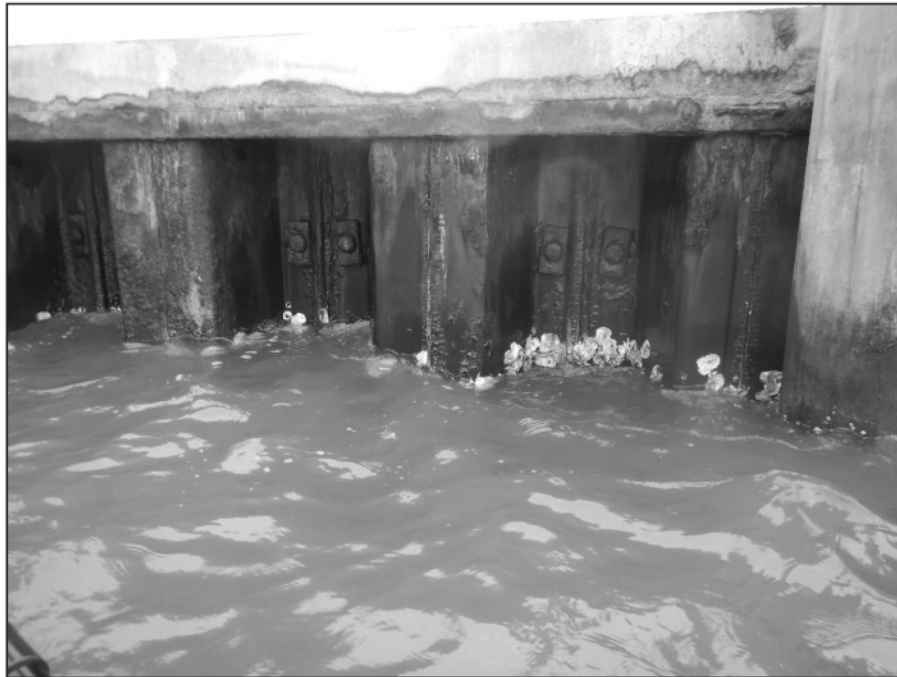
The 2000s steel sheetpile bulkheads are in overall **Fair Condition**, with up to 50% coating loss and light pitting throughout above water portions (see Photo 2-14). Below water, the coating was observed to be intact with no notable deficiencies (see Photo 2-15). Specific locations, deficiencies, and photograph reference are identified in Table 2-2 below. Refer to Appendix B for ultrasonic thickness readings.

Photo 2-14 - Typical Above Water Condition of 2000s Steel (Sta 1+00 Shown)

- The 2000s and later steel sheet pile bulkheads are generally in fair to good condition. No widespread repair or rehabilitation measures are recommended at this time. Based on the existing conditions, it is anticipated that these bulkhead sections have approximately 10 to 20 years of remaining service life.

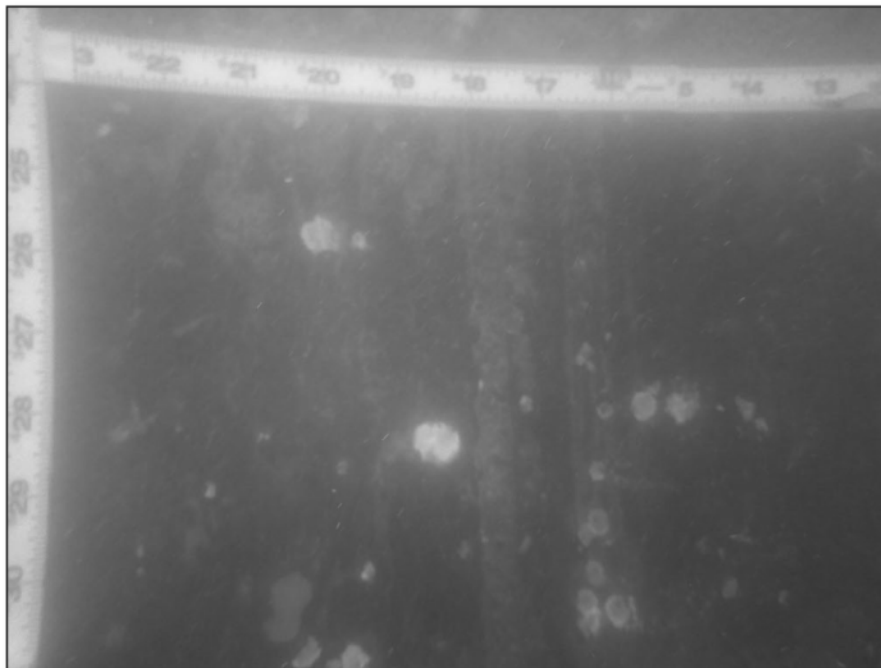
Photo 2-15 – Typical Underwater Condition of 2000s Steel (Coating Intact)

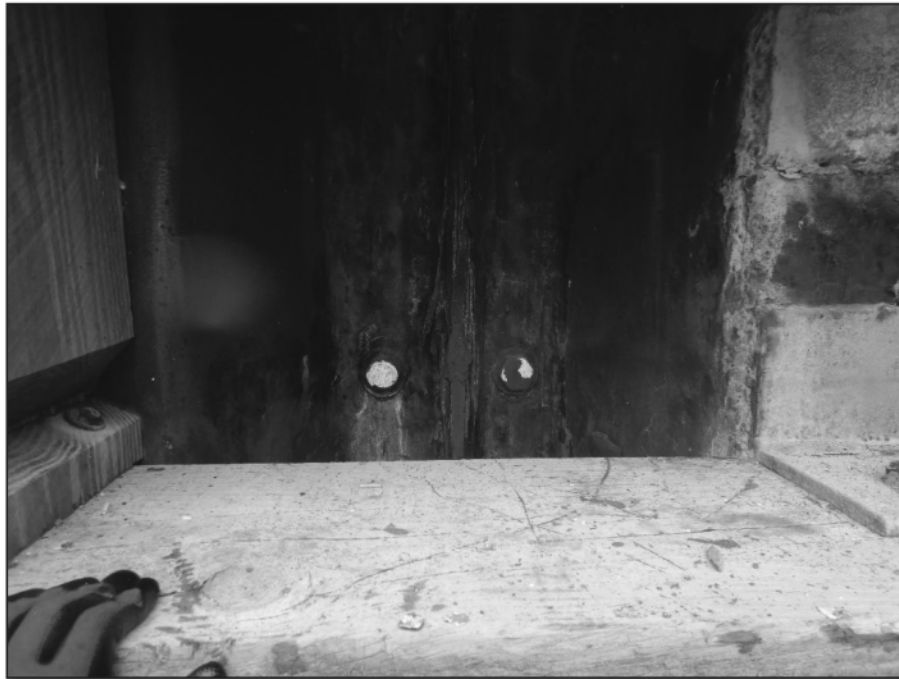
Photo 2-16 – Regular Washers on Tieback Assembly (Sta 70+00-97+50)

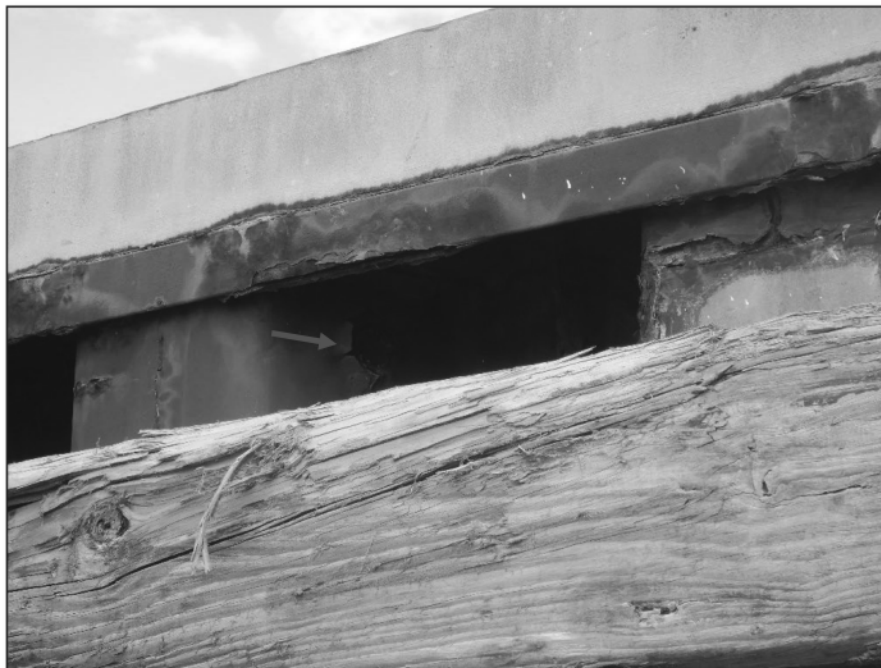
Photo 2-17 – Missing Backing Material to Lifting Holes (70+00-97+50)

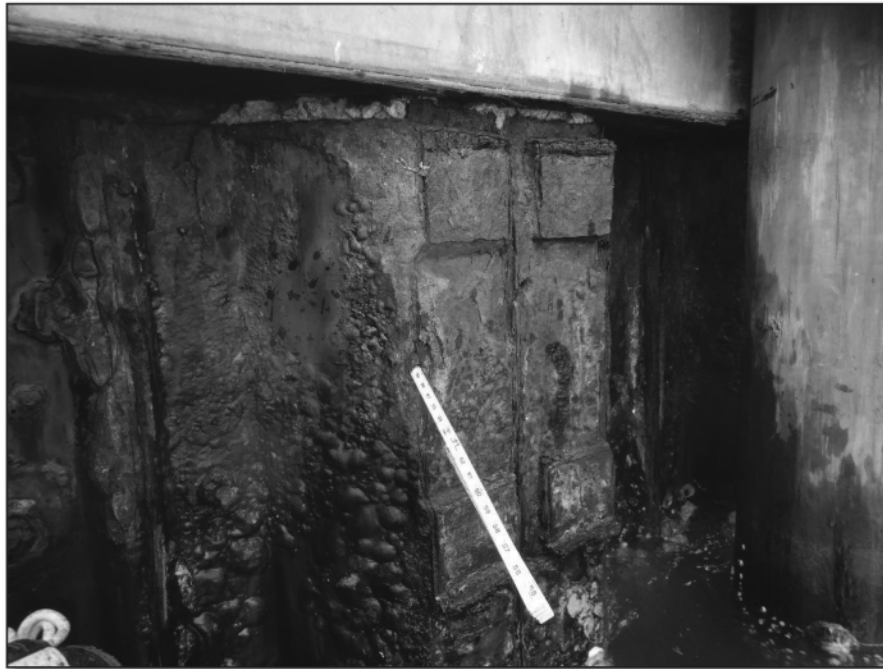
Photo 2-22 – Typical Conditions 31+90-55+91 (corrosion hole at 37+00)

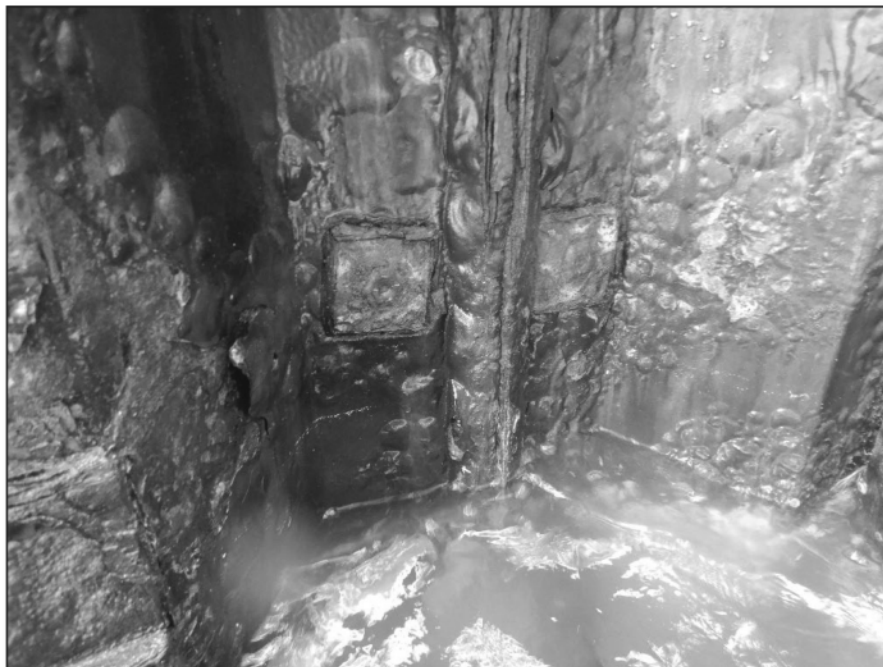
Photo 2-23 – Typical Conditions 31+90-55+91 (~100% loss of tie-back bolt heads)

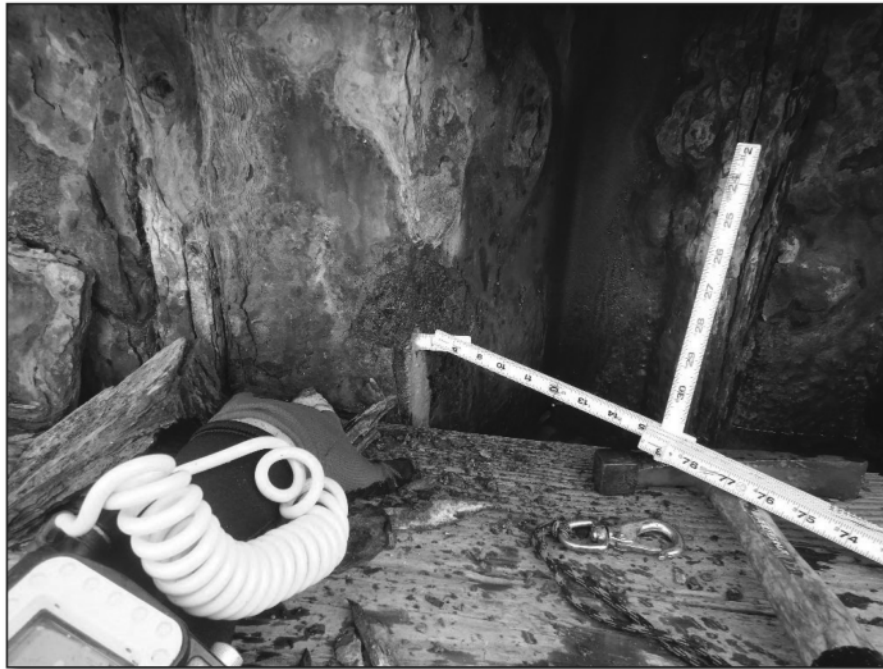
Photo 2-26 – Typical Conditions 62+85-70+00 (corrosion hole at 69+80)

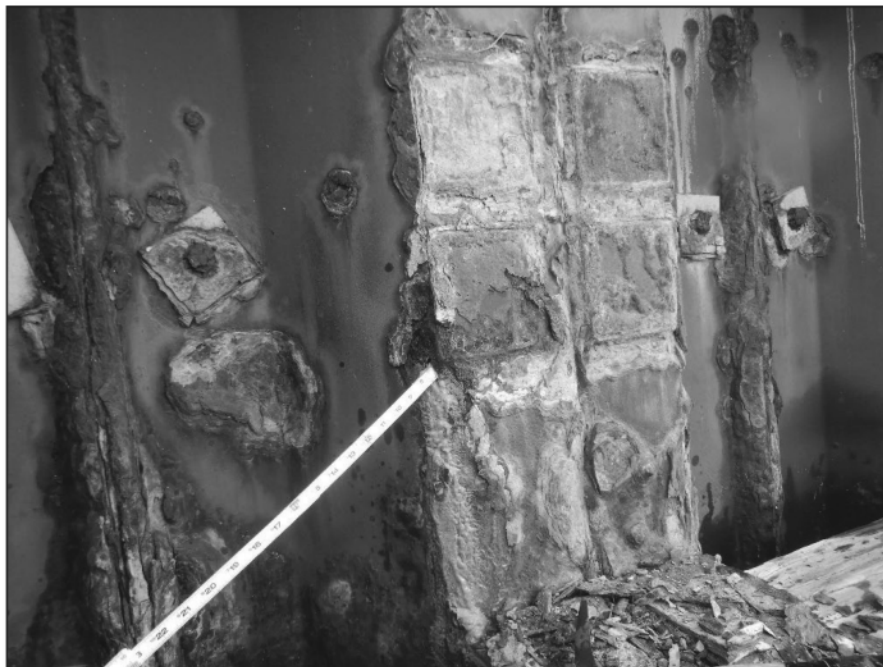
Photo 2-29 – Typical Conditions 110+80-120+50 (corrosion hole at 116+00)

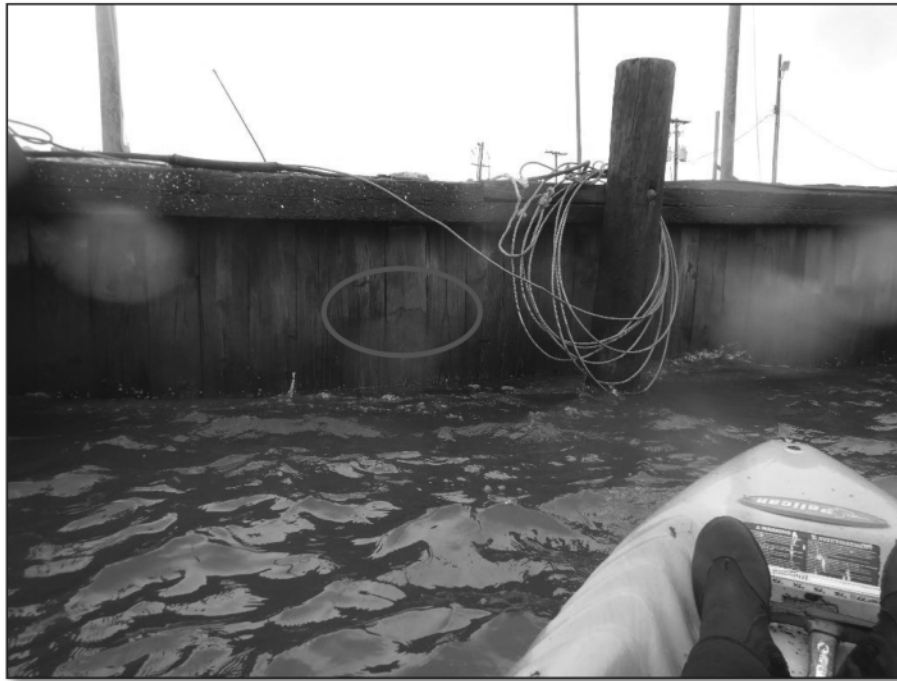
The older vintage timber sheeting bulkheads at the north end of Turning Basin #1 are in overall **Serious Condition**, with horizontal settlement, heavy deterioration and rot, with sinkholes throughout the immediate vicinity (see Photo 3-1). Below water, the timber sheets typically exhibit rot with moderate marine growth (see Photo 3-2). Specific locations, deficiencies, and photograph reference are identified in Table 3-1 below.

Photo 3-1 - Older Vintage Timber Sheeting Exhibiting Split Planks (Sta 12+50 Shown)

- The timber bulkhead at the north end of Turning Basin #1 is in severe condition due to the advanced deterioration of the timber elements and horizontal displacement. Based on the existing conditions, the bulkhead is at the end of its useful services life. It is recommended that this portion of wall be replaced with a new steel sheet pile bulkhead. Our rough order of magnitude conceptual cost estimate for this repair is approximately \$3.5M for 781 linear feet of bulkhead, or approximately \$4,500/ft. Note that this repair recommendation and cost estimate includes the deteriorated concrete bulkheads at the north end of Turning Basin #1 from 7+04 to 14+85.

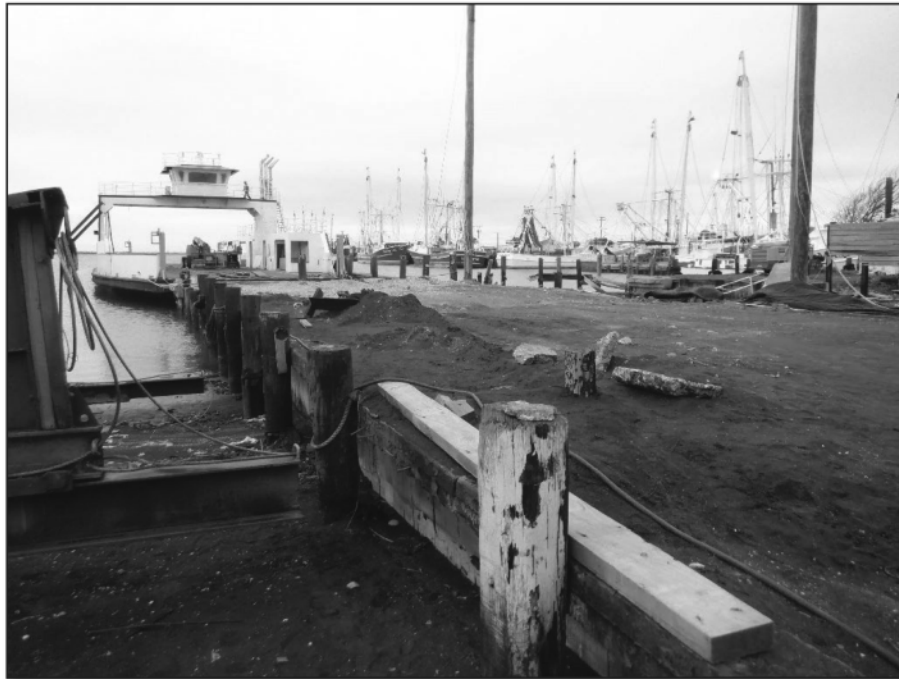
Photo 3-3 – Seaward Settlement (Sta 9+85-12+16)

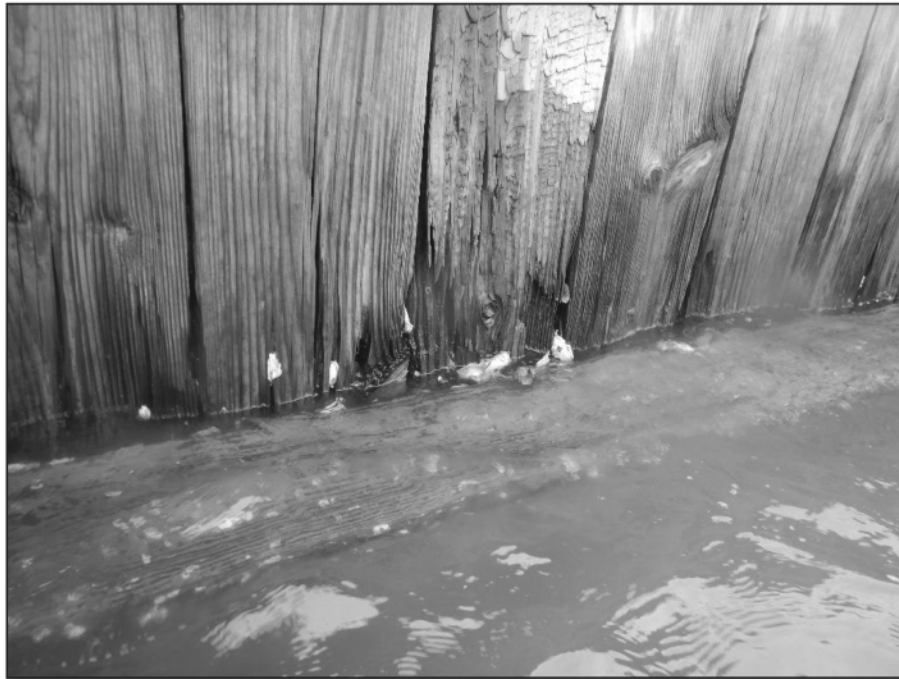
Photo 3-5 – Heavy Deterioration and Rot in Timber Sheeting (Sta 13+30-13+66)

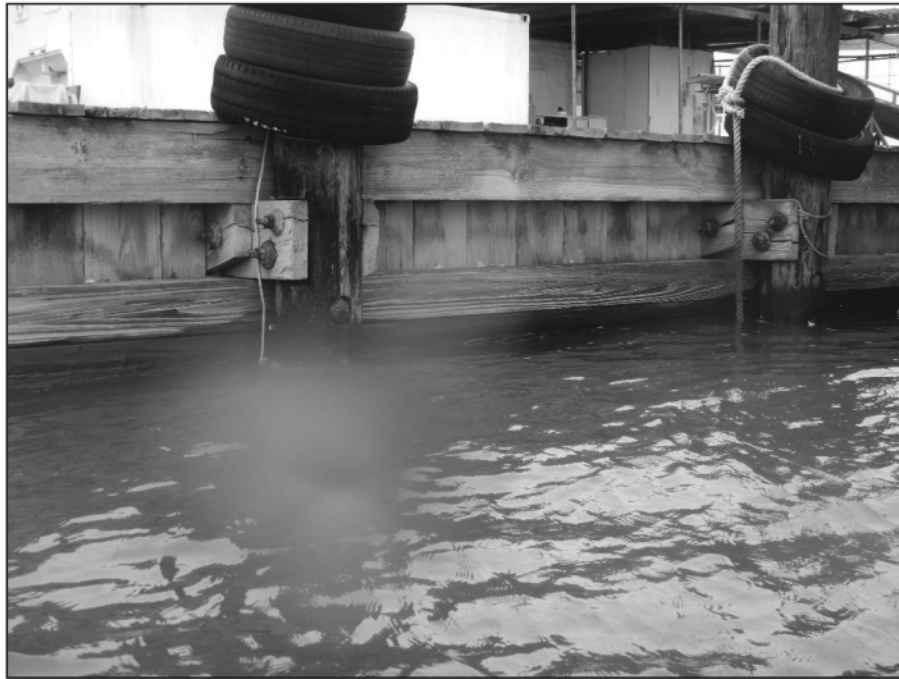
Photo 3-7 – Heavy Corrosion in Steel Fasteners at 1987 Timber Sheeting (Sta 16+60-18+48)

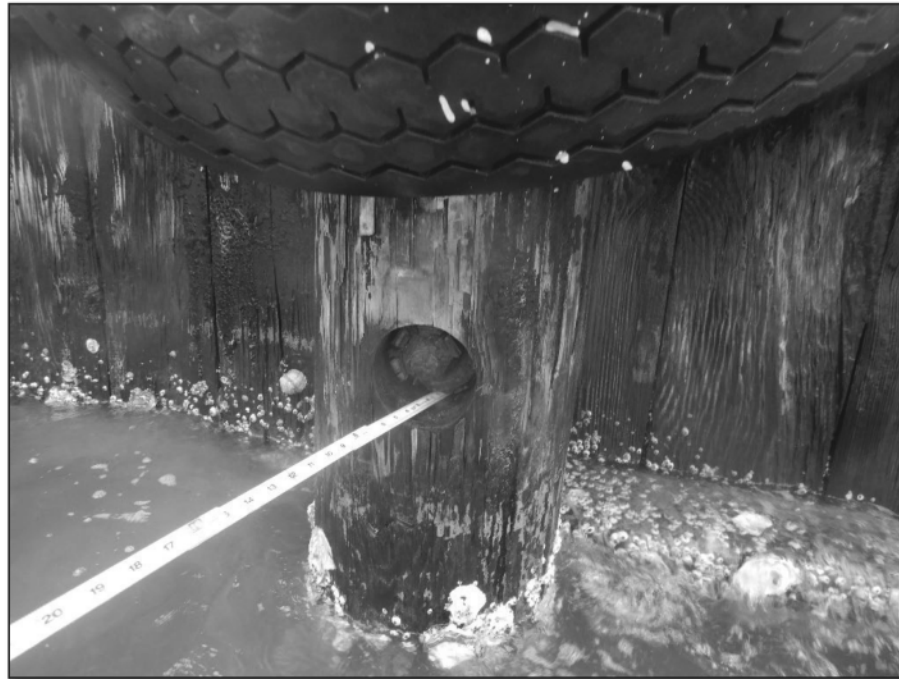
Photo 3-9 – ~100% Section Loss of the Tie-Back Rod Nuts (3+34 to 5+20)

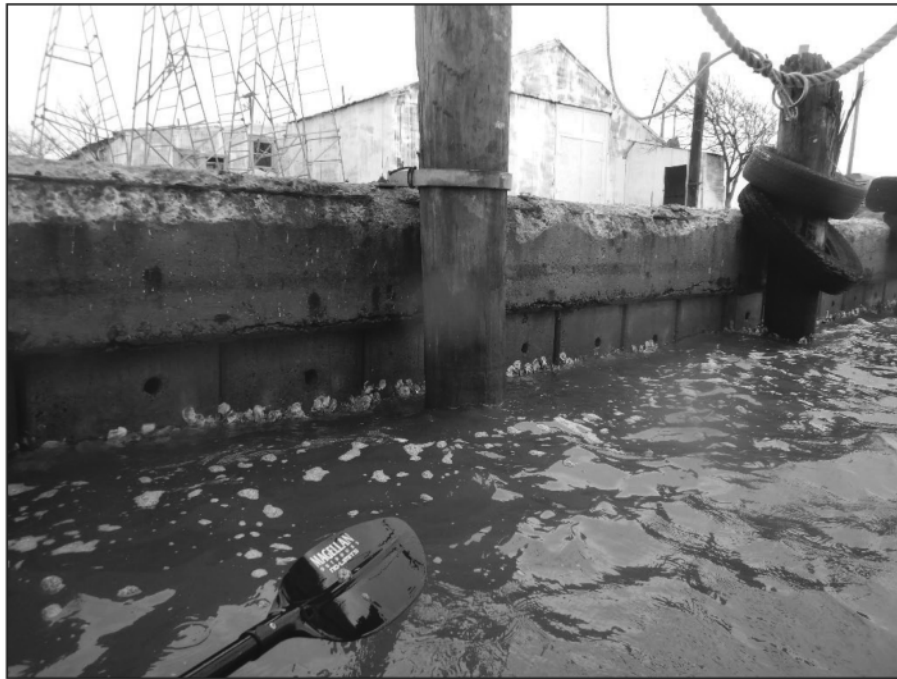
Photo 4-1 – Typical Above Water Condition of Concrete Sheet piling North of Turning Basin 1
(Sta 14+50 Shown)

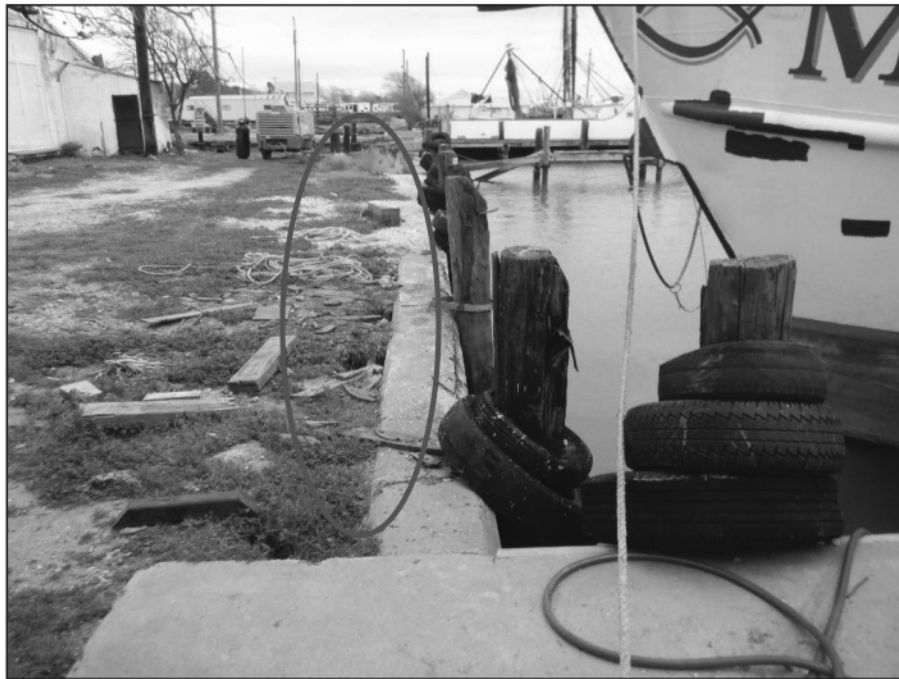
Photo 4-3 - Sinkholes with Active Fill Loss (Sta 14+85 Shown) (Some Gravel Filled)

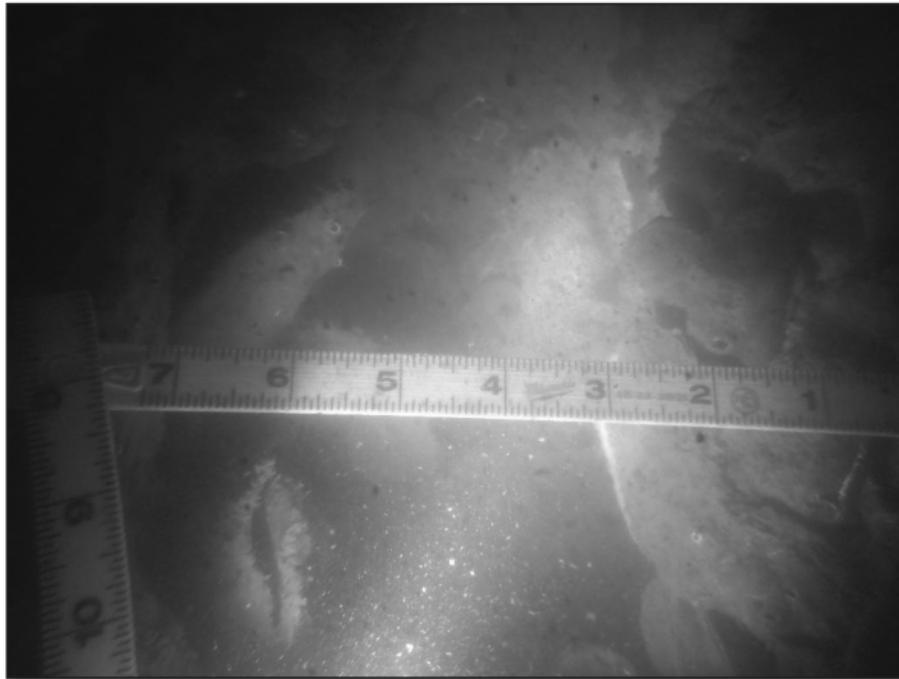
Photo 4-4 – 10”W x 6’H Gap in Sheets with Fill Visible at 27+30 (Apparent Construction Defect)

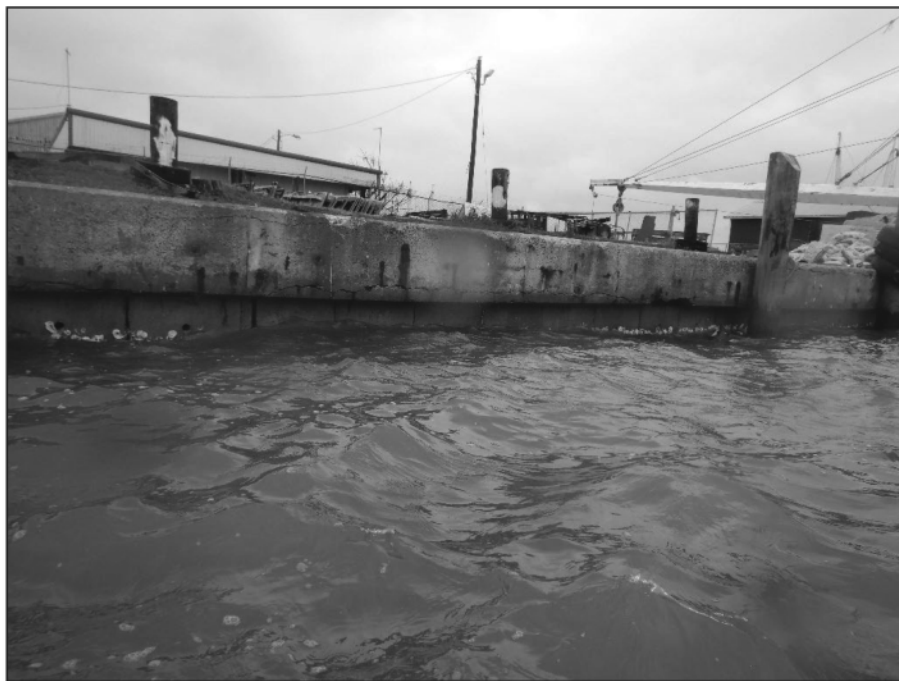
Photo 4-5 – Edge Spalls and Longitudinal Cracking with Rust Staining (Sta 28+85-31+90)

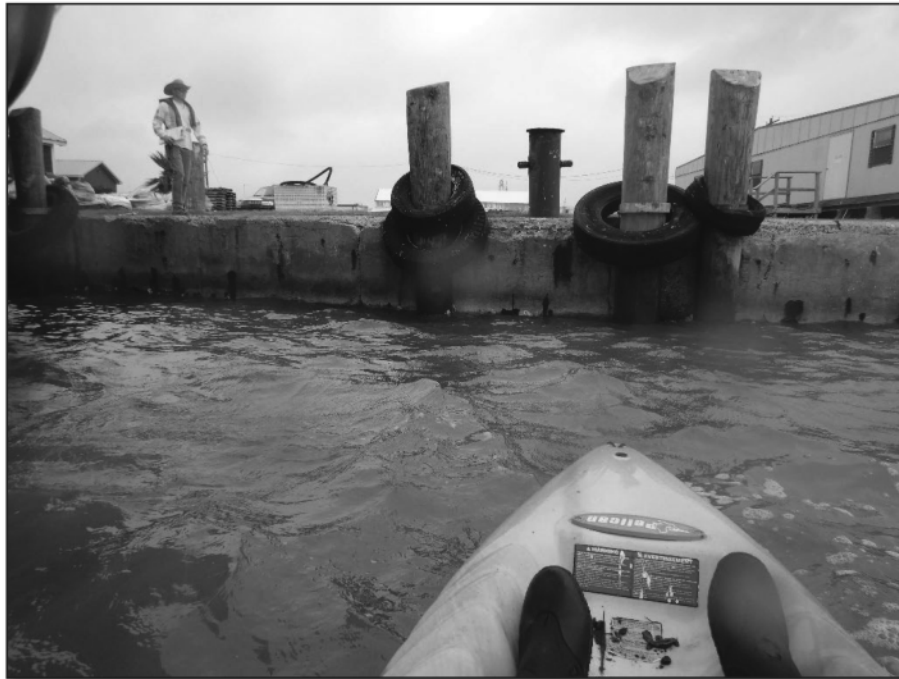
Photo 4-6 – Edge Spalls and Longitudinal Cracking with Rust Staining (Sta 28+85-31+90)

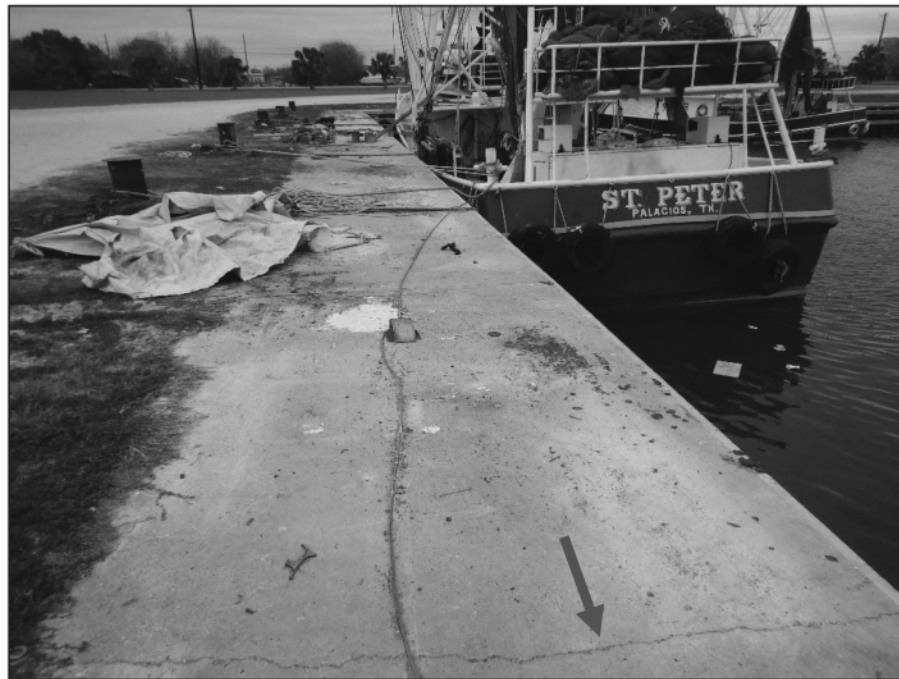
Photo 6-1 – Typical Condition of Topside, with Intermittent Transverse Cracks

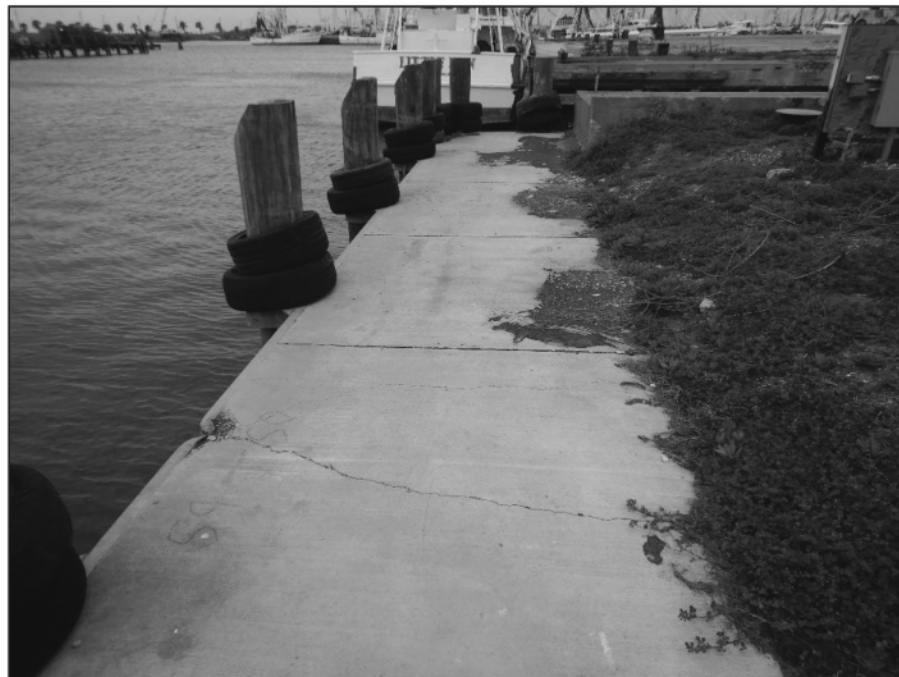
Photo 6-2 – Minor Impact Damage at Sta 59+50

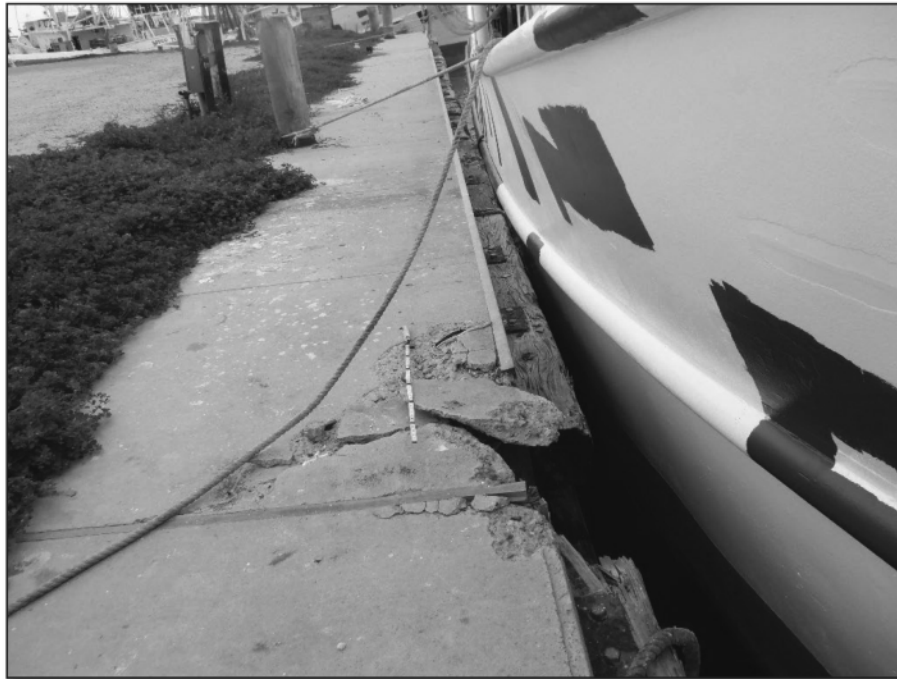
Photo 6-3 – Impact Damage at Sta 66+60

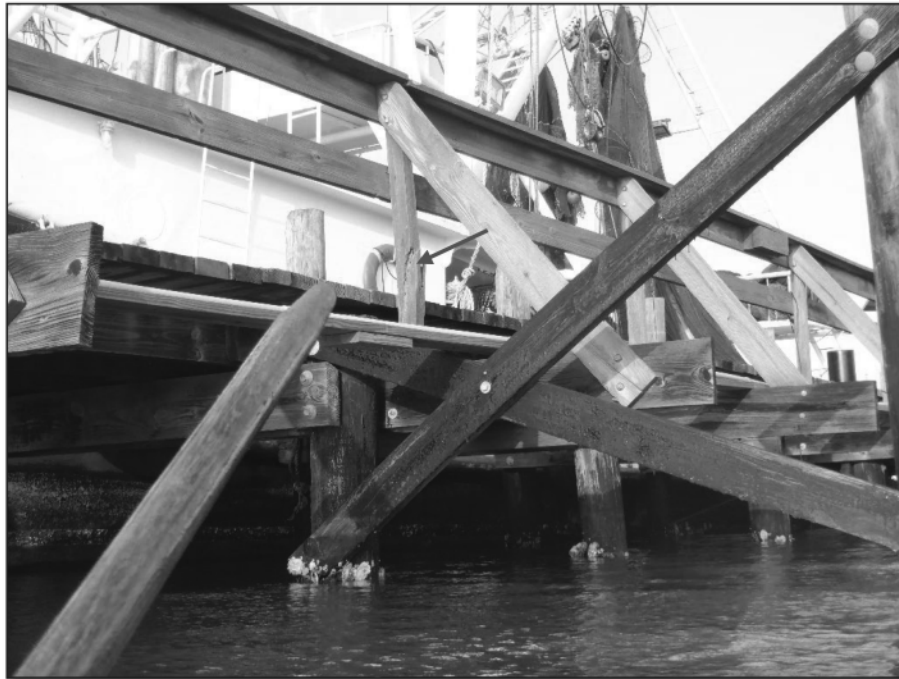
Photo 7-7 – Failed Handrail at Pier 1
