**Application for the Maritime Administration’s Port Infrastructure Development Program (PIDP)
Under the Infrastructure Investment and Jobs Act (“Bipartisan Infrastructure Law”)**

**Matagorda County Navigation District #1 dba the Port of Palacios
Energy & Resilience Improvement Project (ERIP)
Matagorda County, Texas**

PROJECT NARRATIVE

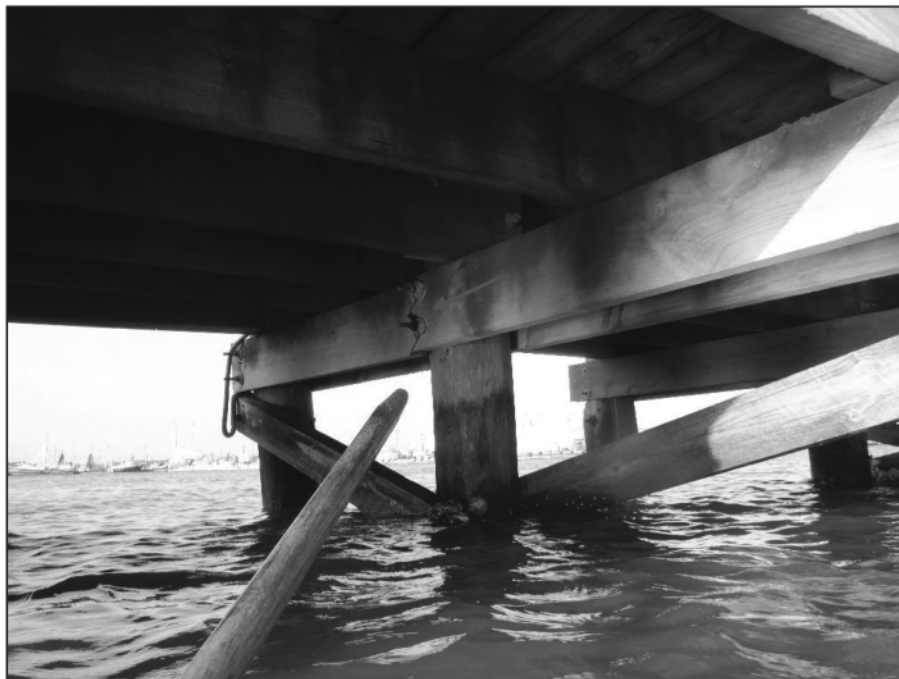
Photo 7-8 – Split Pile Cap at Pier 1

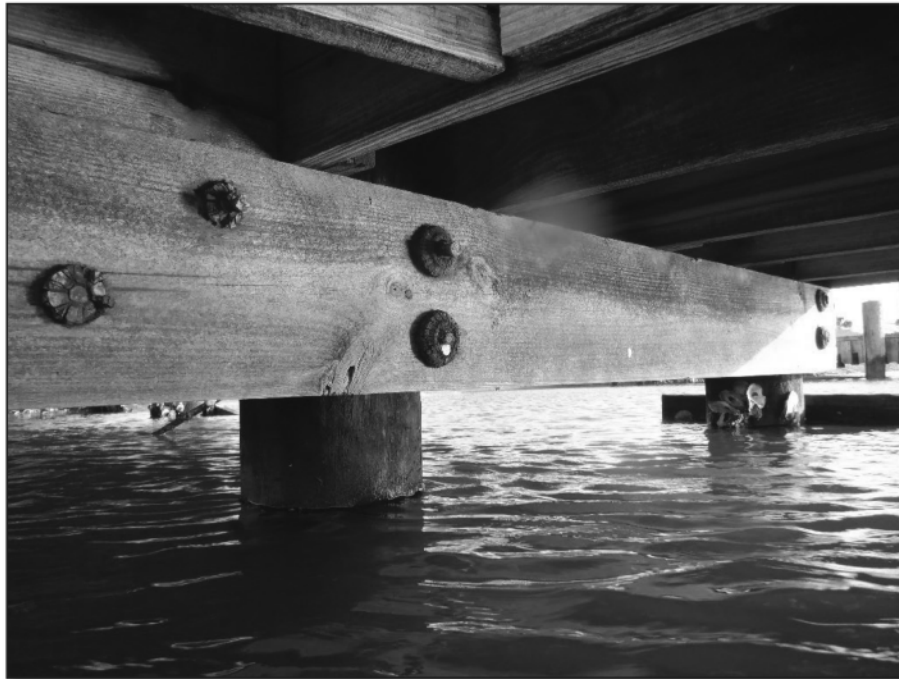
Photo 7-9 – Severe Corrosion in Pile Cap Hardware at Piers 2 and 3

- Immediate repair items (within 6 months): Discrete repair of Piers 2, 3, 4, and 5. These repairs consist of repairs to the hardware, substructure, superstructure, deck, handrails, and bracing.

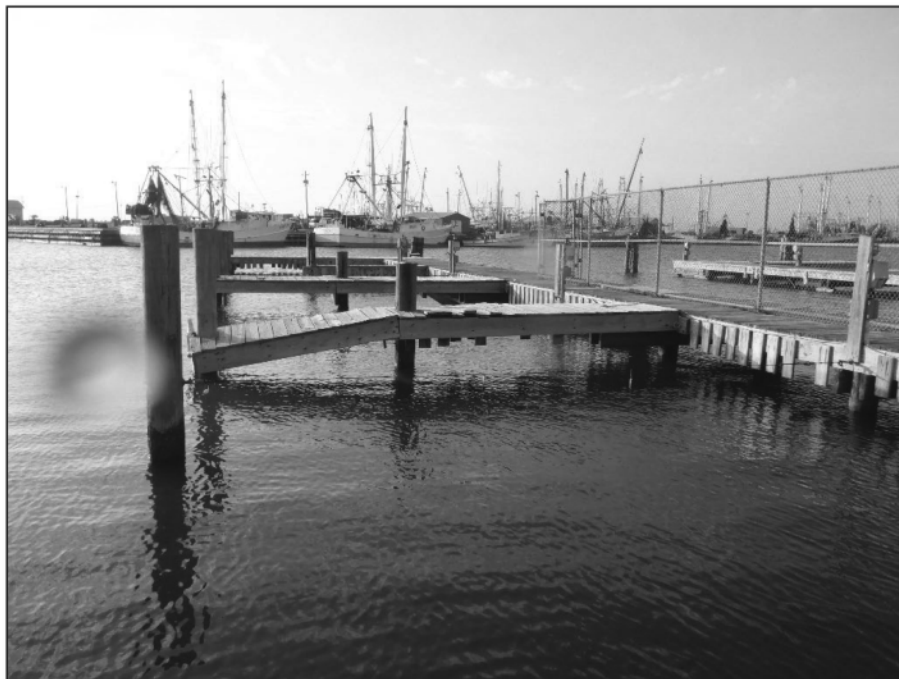
Photo 7-10 – Failed Finger at Pier 3

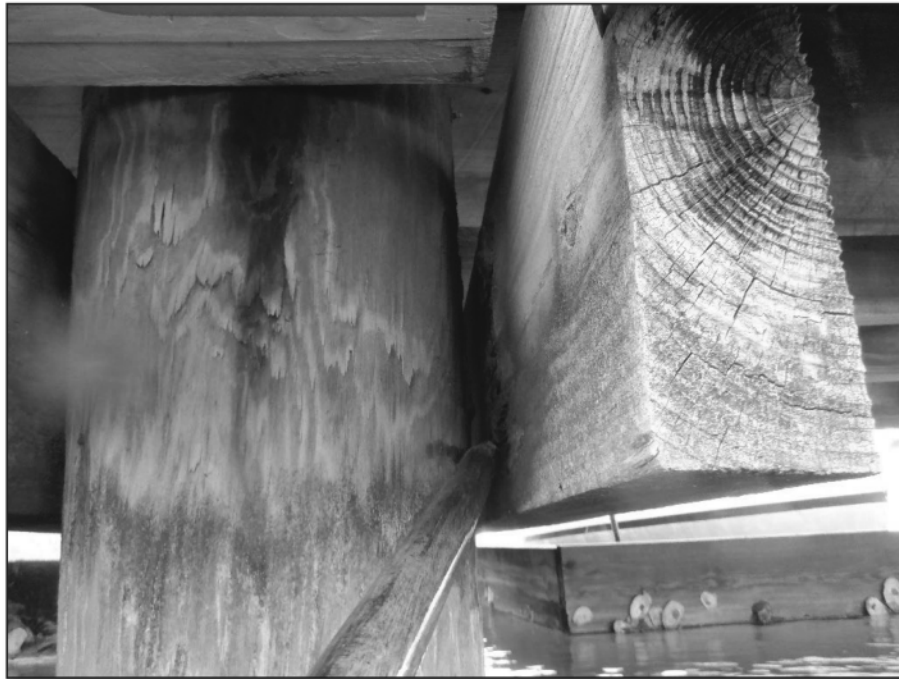
Photo 7-11 – Failed Pile Cap Hardware at Pier 4

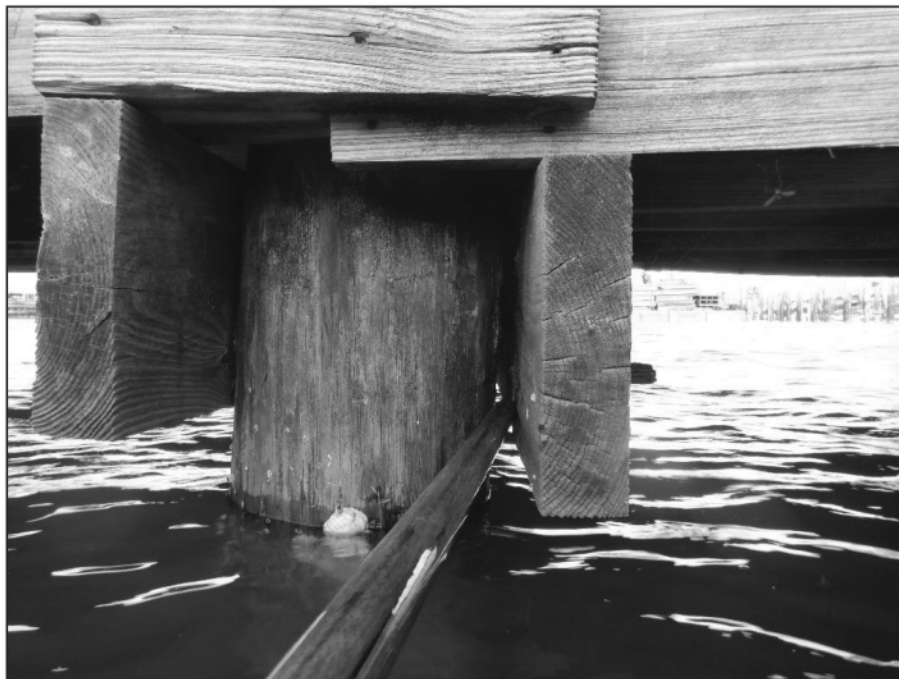
Photo 7-12 – Failed Pile Cap Hardware at Pier 5

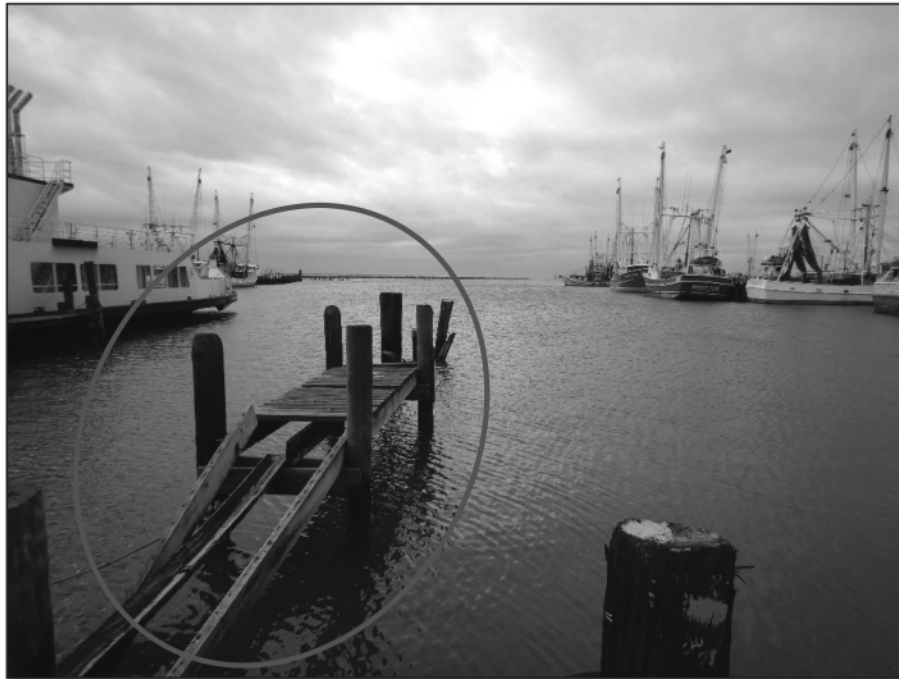
Photo 7-14 – Western Pier in State of Disrepair Adjacent to Marine Railways

- Piers at the north end of Turning Basin #1: Based on the existing conditions, the piers are at the end of their useful service lives. Our rough order of magnitude opinion of probable construction costs for removing and replacing the piers is \$120k each, or \$240k for both.

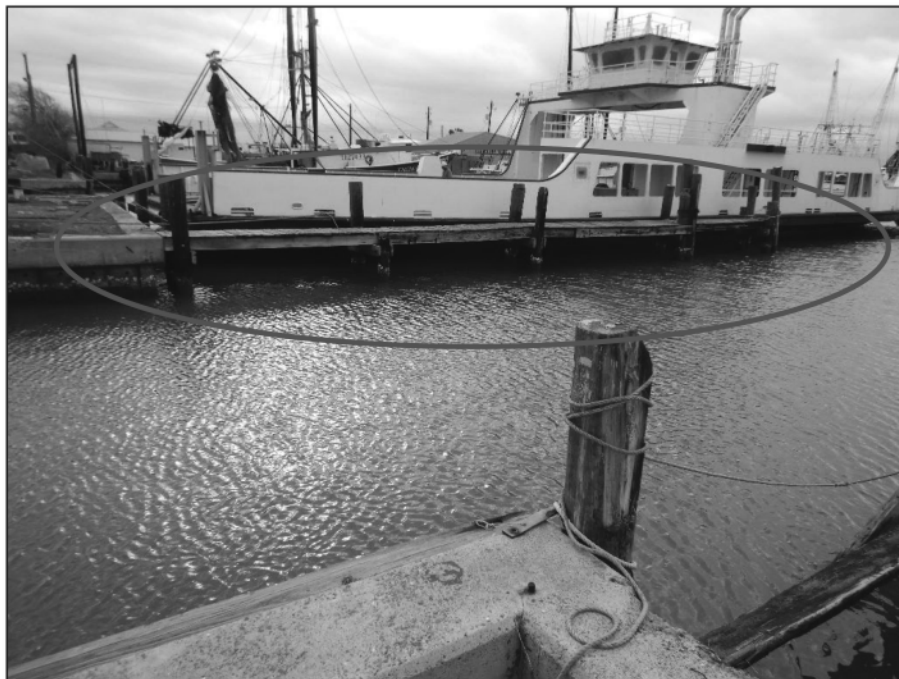
Photo 7-15 – Eastern Pier in Severe Condition Adjacent to Marine Railways

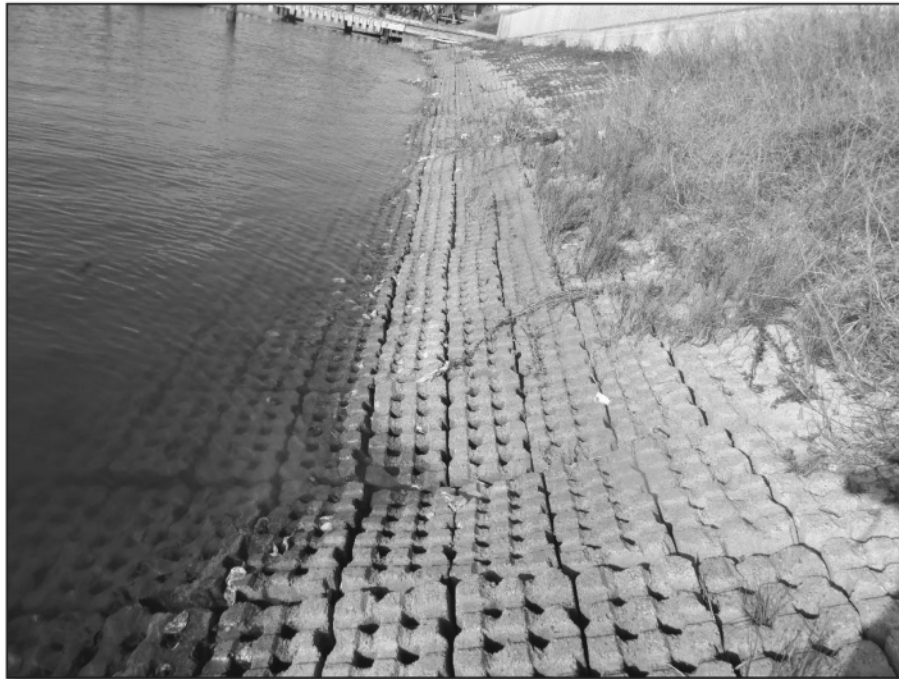
Photo 8-3 – ACM Typical Settlement
