**Application for the Maritime Administration’s Port Infrastructure Development Program (PIDP)
Under the Infrastructure Investment and Jobs Act (“Bipartisan Infrastructure Law”)**

**Matagorda County Navigation District #1 dba the Port of Palacios
Energy & Resilience Improvement Project (ERIP)
Matagorda County, Texas**

PROJECT NARRATIVE

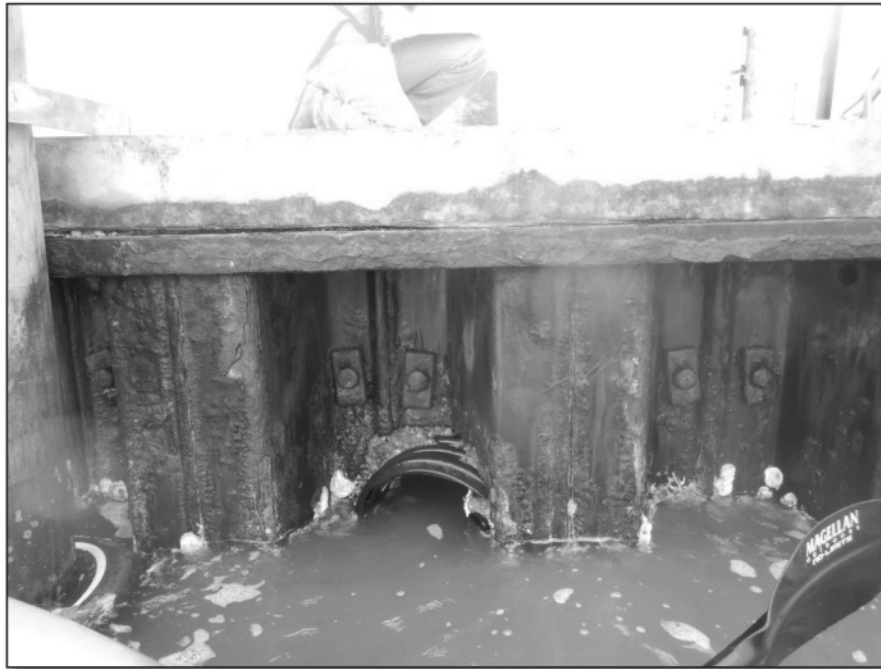
Photo 2-18 – Typical Conditions 0+00-1+88 (Outfall at 0+25)

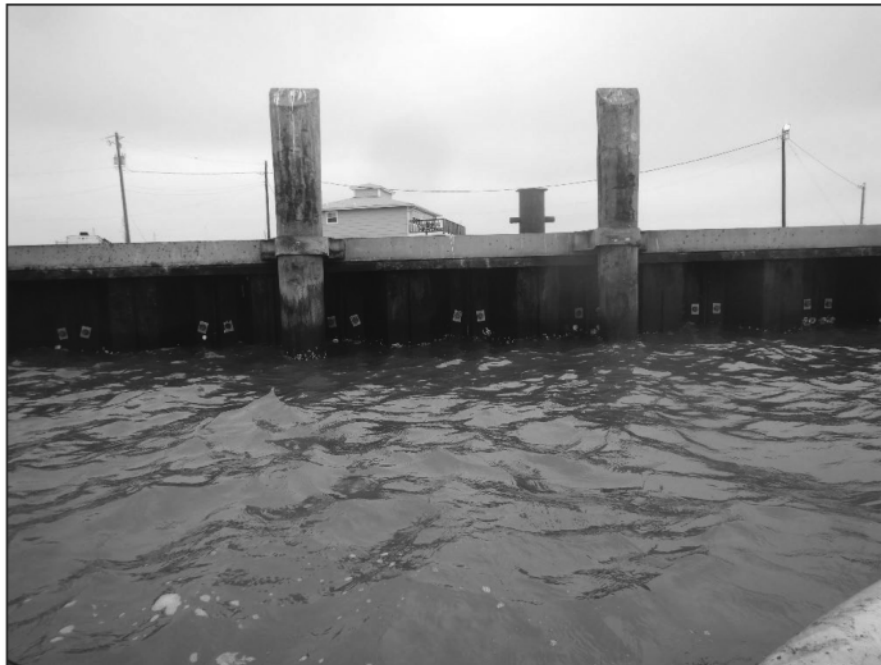
Photo 2-19 – Typical Conditions 1+88-3+34

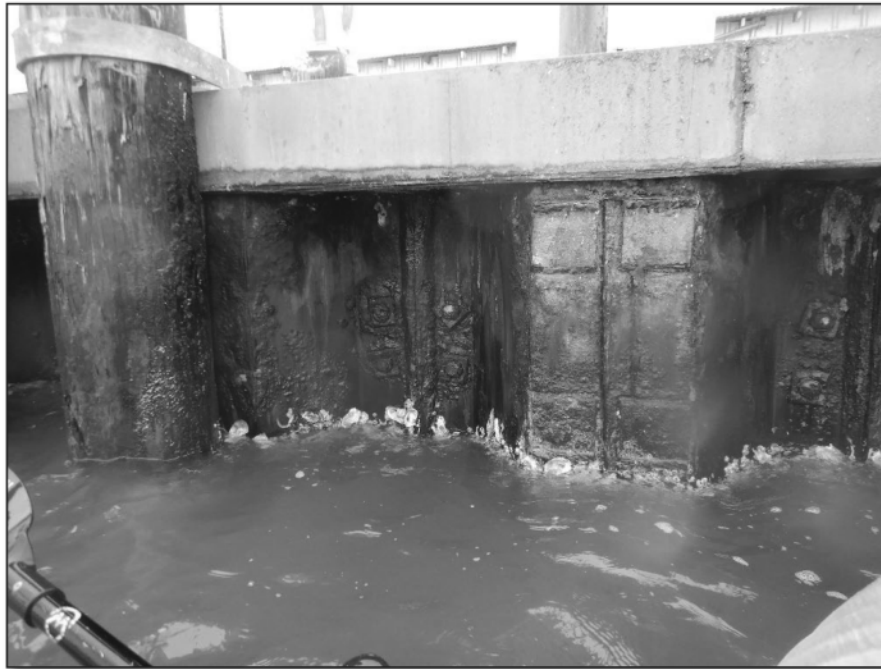
Photo 2-20 – Typical Conditions 5+20-7+04

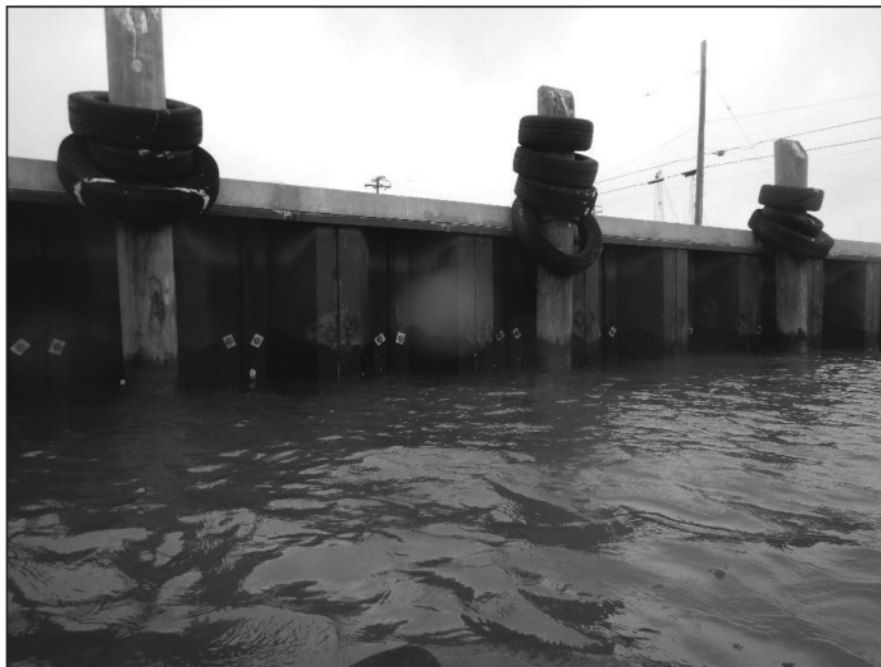
Photo 2-21 – Typical Conditions 19+68-24+79

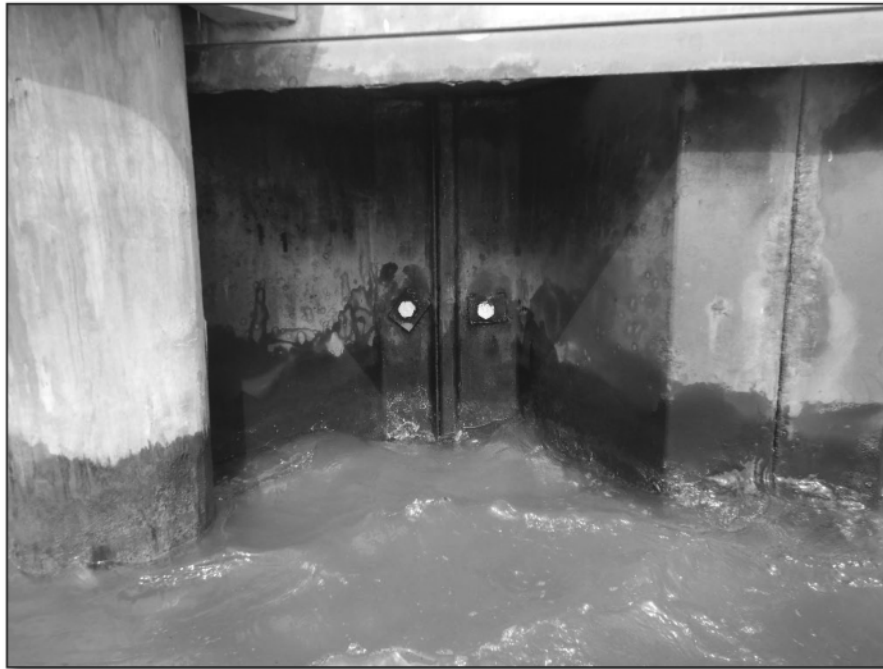
Photo 2-24 – Typical Conditions 55+91-59+83

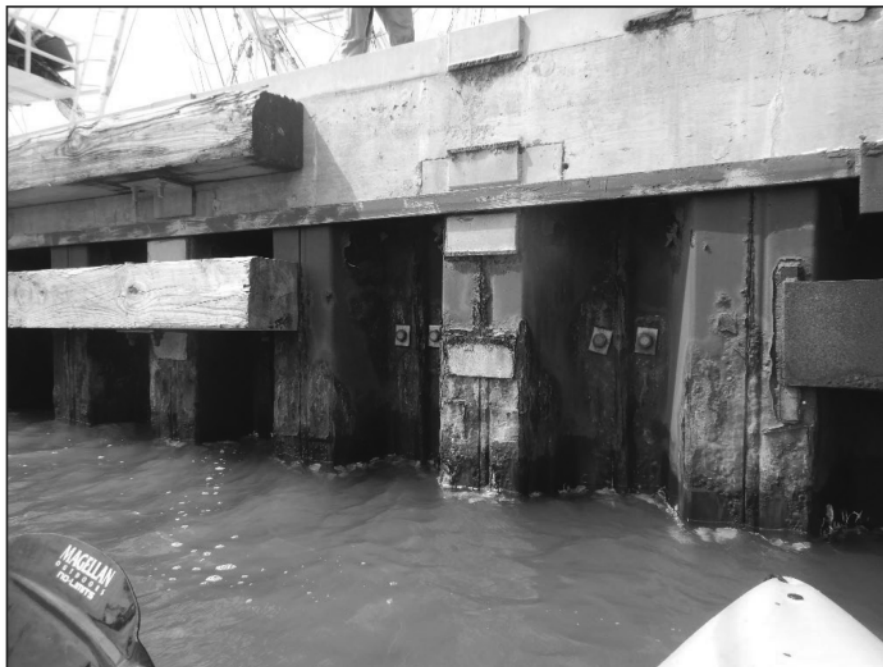
Photo 2-25 – Typical Conditions 59+83-62+85 (boat lift)

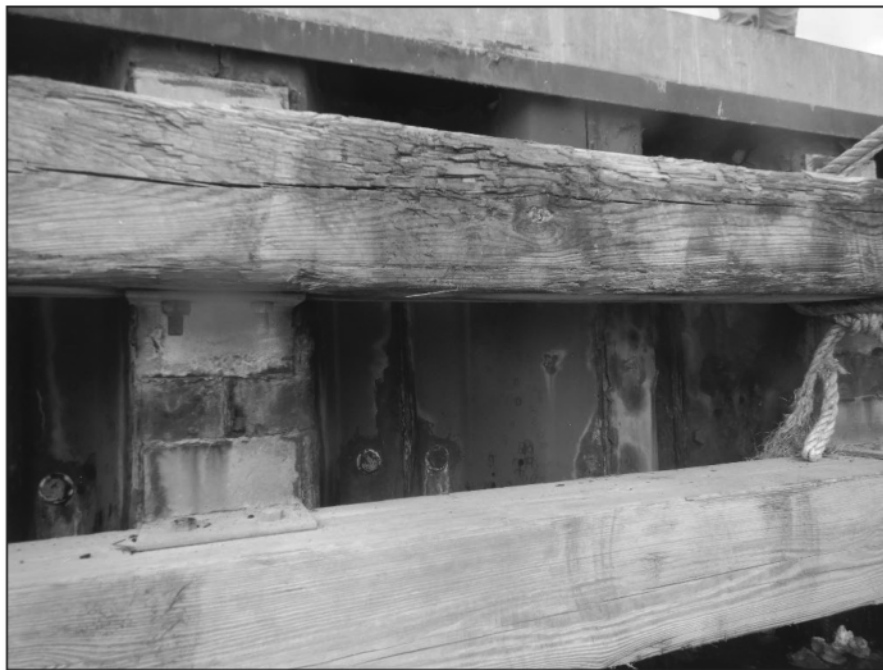
Photo 2-27 – Typical Conditions 70+00-97+50

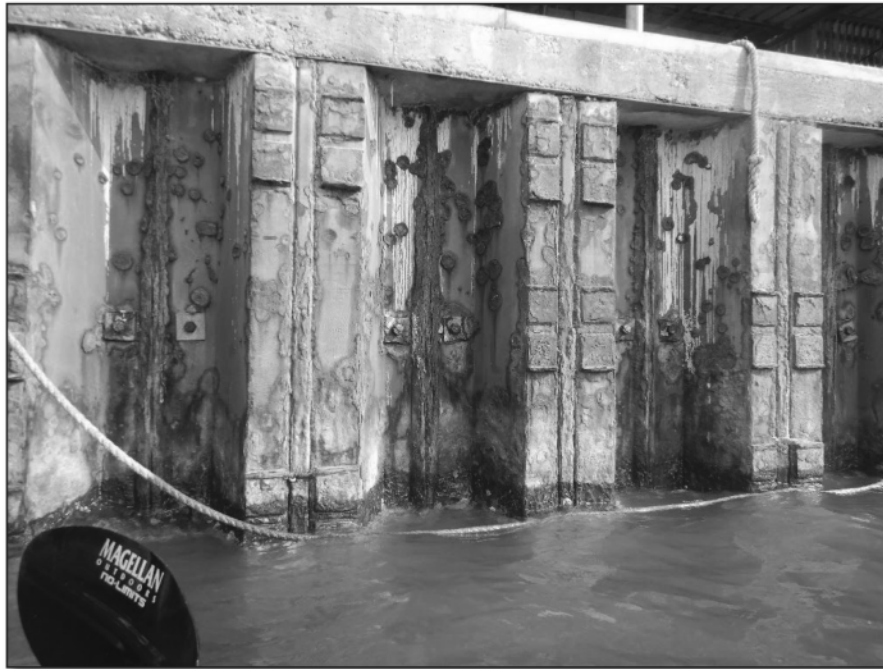
Photo 2-28 – Typical Conditions 97+50-110+80

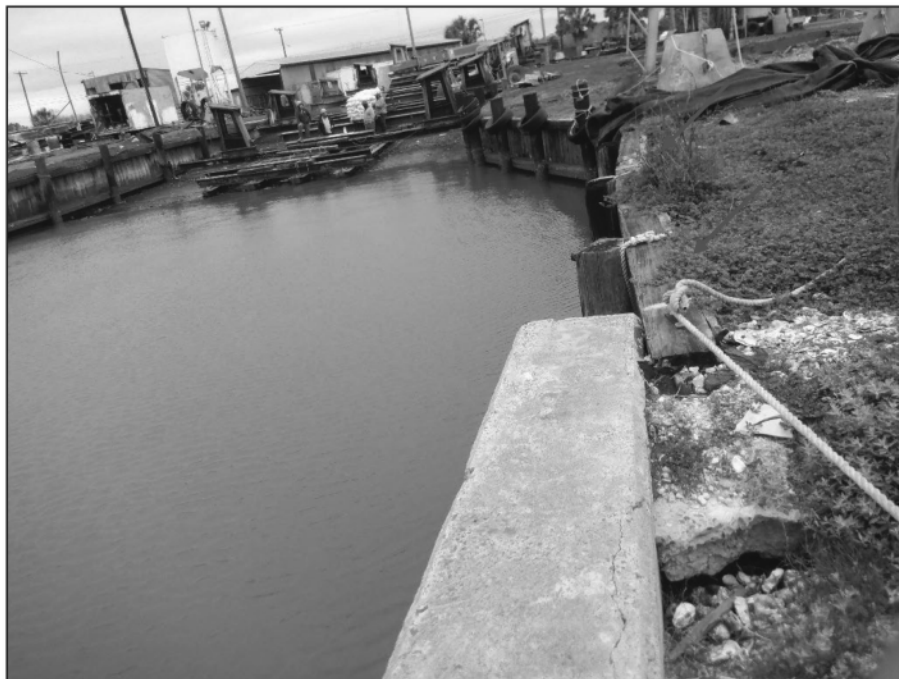
Photo 3-4 – Seaward Settlement and Sinkholes Throughout (Sta 9+85-12+16)

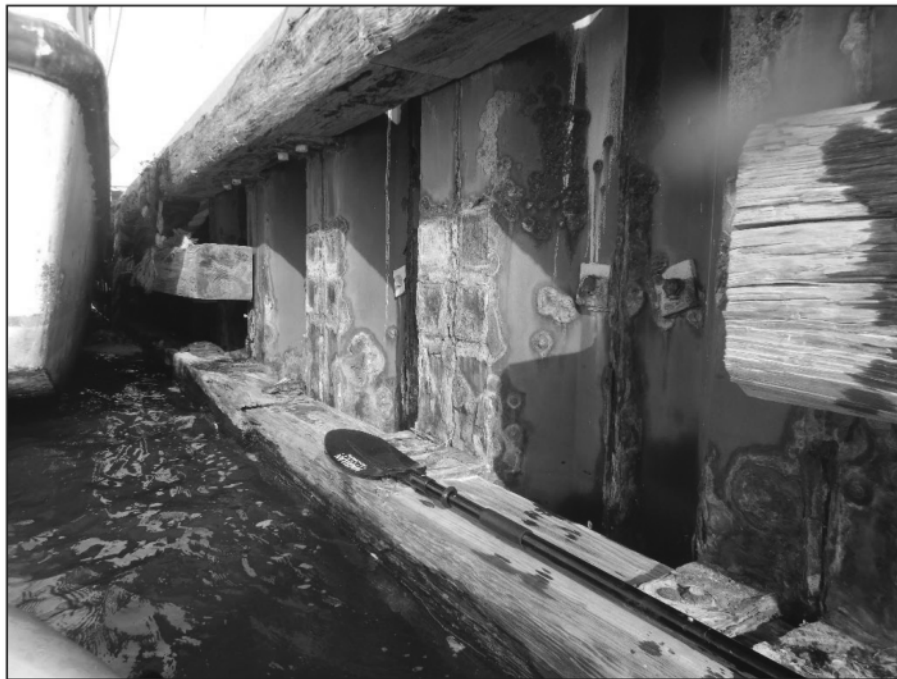
Photo 5-1 – Typical Condition of 1980s Fender System

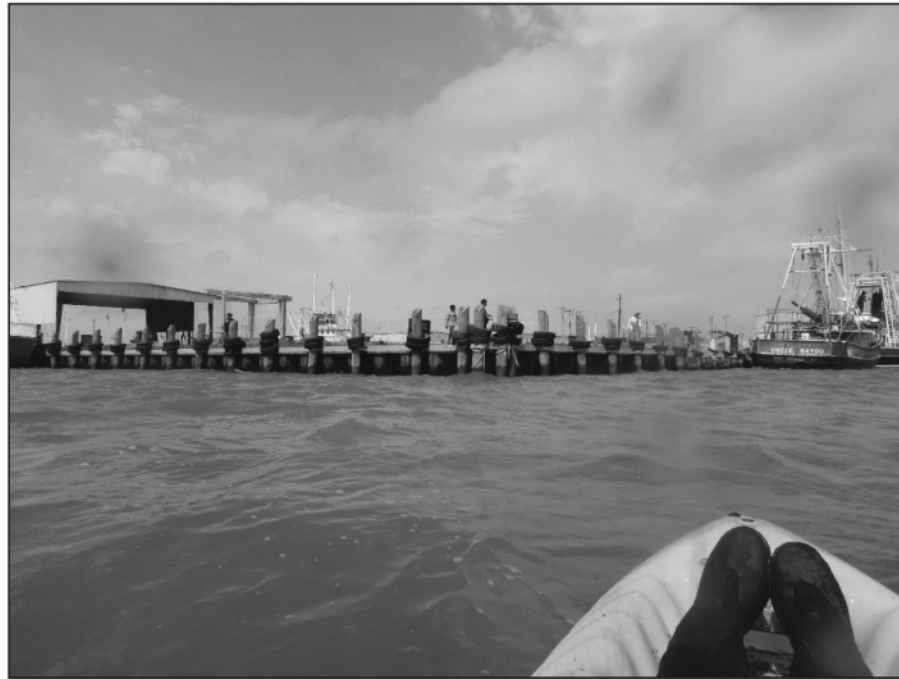
Steel pipe mooring/fender piles were installed between Sta 45+74 and 54+50. These piles are in good condition. UT readings of the piles in the splash zone to the mudline were typically 0.250", with no indications of section loss.

Photo 5-2 – Typical Condition of Fender Piles

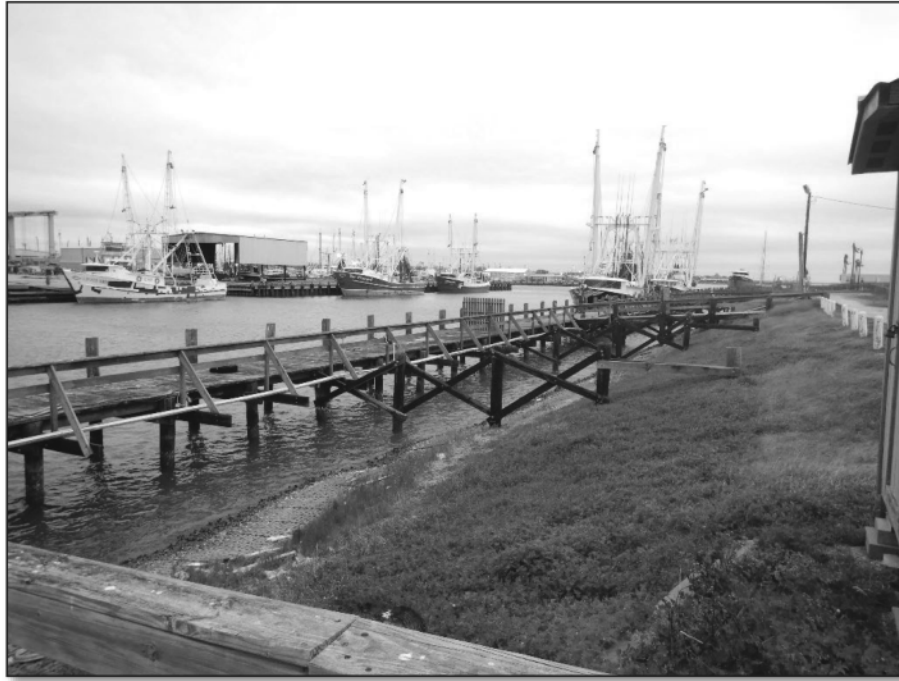
Photo 7-1 – Pier 1 Looking East

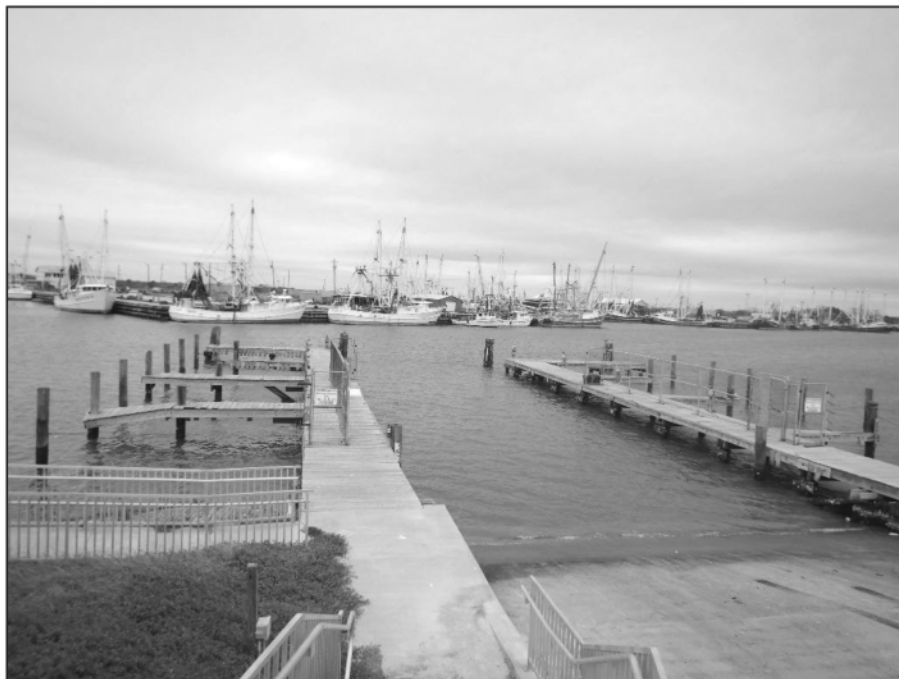
Piers 2 and 3 are approximately 150 ft long x 8 ft wide and 165 ft long x 8 ft wide L-shape timber structures, respectively. Both structures consist of decking and stringers supported by split pile caps and piles (see Photo 7-2). Three timber fingers at each pier are intermittently spaced for the docking of small, recreational vessels.

Photo 7-2 – Piers 2 and 3 Looking North

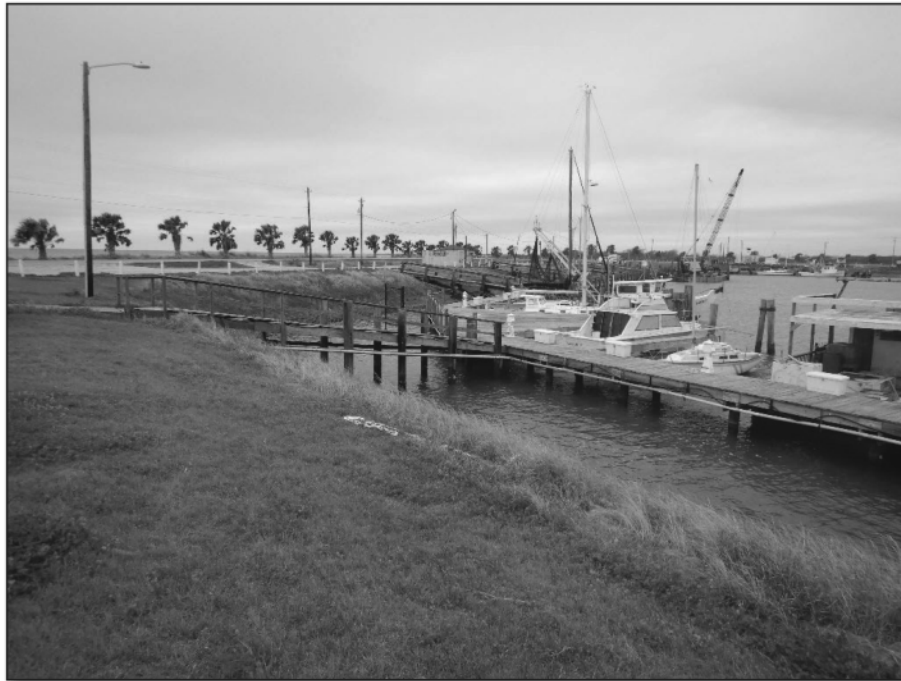
Photo 7-3 – Pier 4 Eastern Portion Looking West

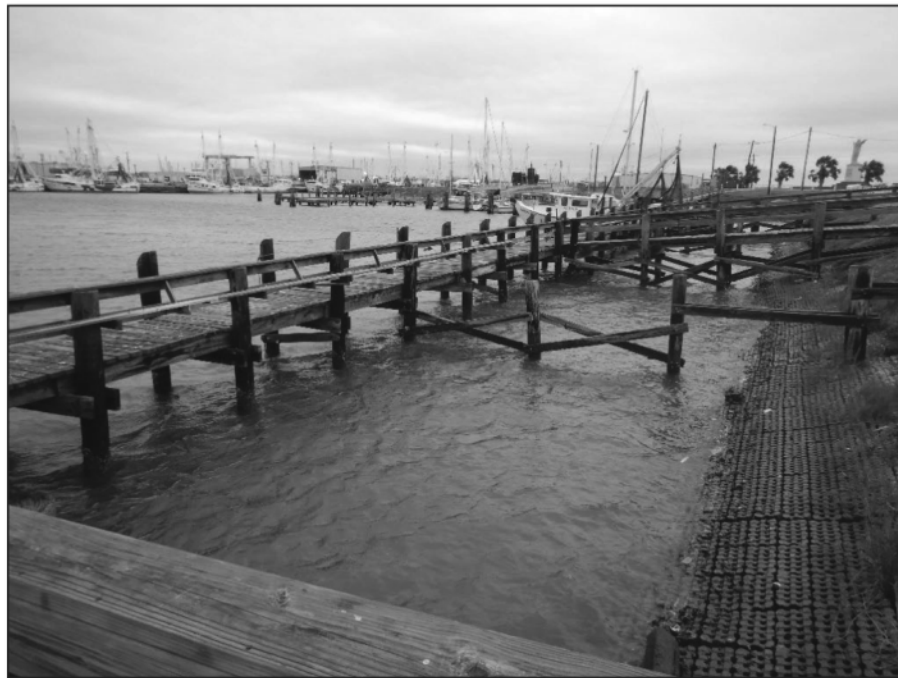
Photo 7-4 – Pier 4 Creosote Timber Portion Looking East

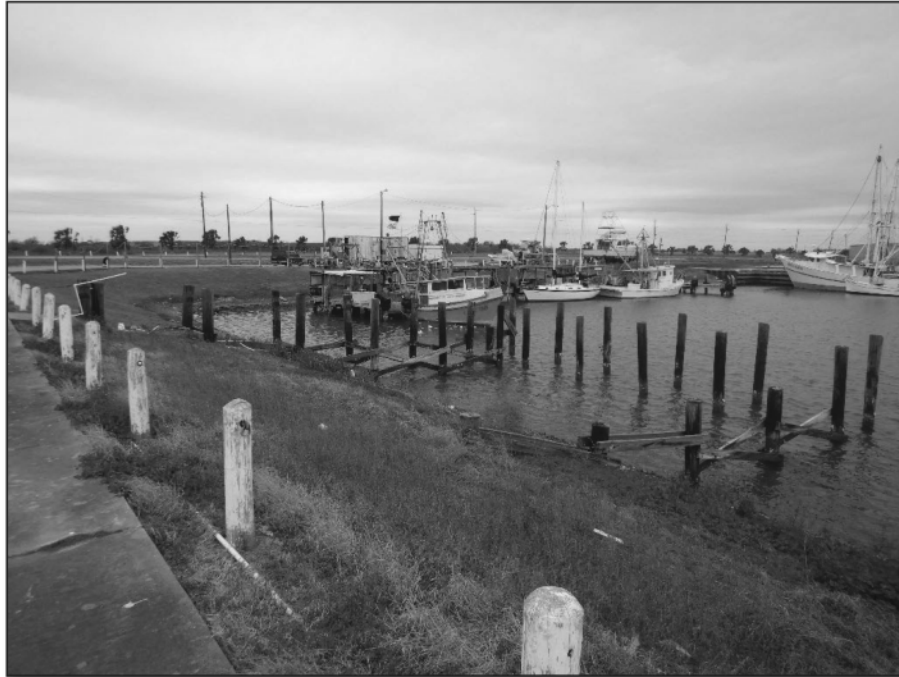
Pier 4 is approximately a 725 ft long timber structure varying in configuration and construction. Approximately 225 linear feet of the eastern portion of Pier 4 is primarily 8 ft wide at finger pier access locations, with a portion thereof that is approximately 50 ft long x up to 40 ft wide. The eastern portion consists of timber decking, stringers supported by split pile caps, and piles. One timber access trestle provides access to this location. Four timber finger piers are intermittently spaced for docking of small, recreational vessels (see Photo 7-3). The remaining, approximately 500 linear ft to Pier 4 consists of a creosote treated timber structure that is approximately 8 ft wide (see Photo 7-4). Six timber trestles are intermittently spaced to provide access throughout the length of the pier section. In addition, lateral bracing bents are intermittently spaced along the pier. Approximately 275 linear feet thereof and along the western portion of Pier 4, the superstructure and deck components to both the pier and access trestles have been removed, the timber piles remain (see Photo 7-5).

Photo 7-5 – Pier 4 Western Portion Looking West

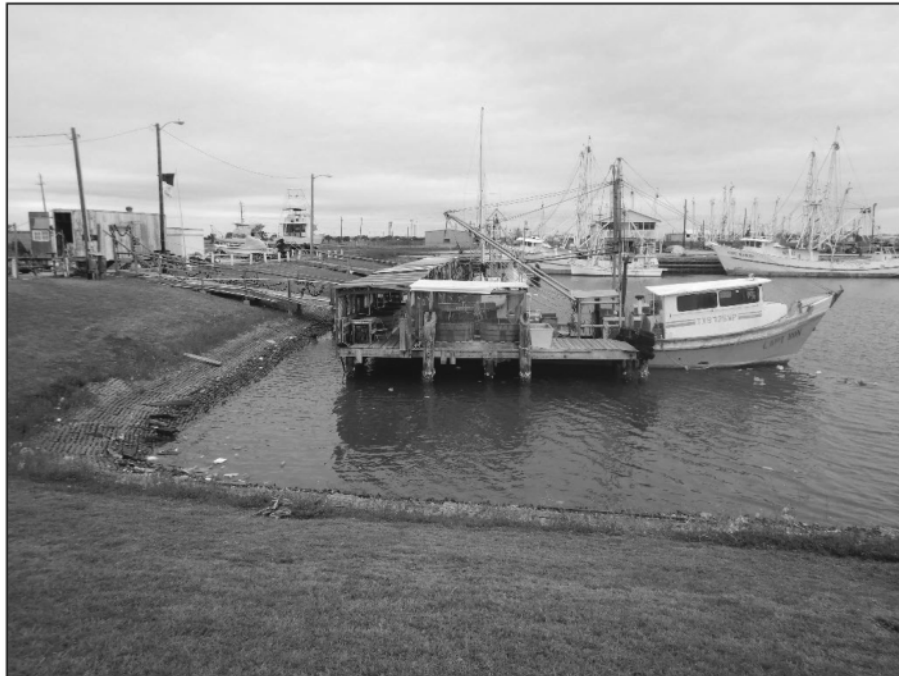
Pier 5 is approximately a 240 ft long x 8 ft wide C-shape timber structure that consists of decking and handrails, stringers supported by split piles caps and piles (see Photo 7-6). Approximately 140 ft of the southern extents of Pier 5 includes a covered structure consisting of a metal roof and associated timber framing and metal fencing. Refer to the drawings and figures provided in Appendix A for approximate locations and specific configurations.

Photo 7-6 – Pier 5 Looking North

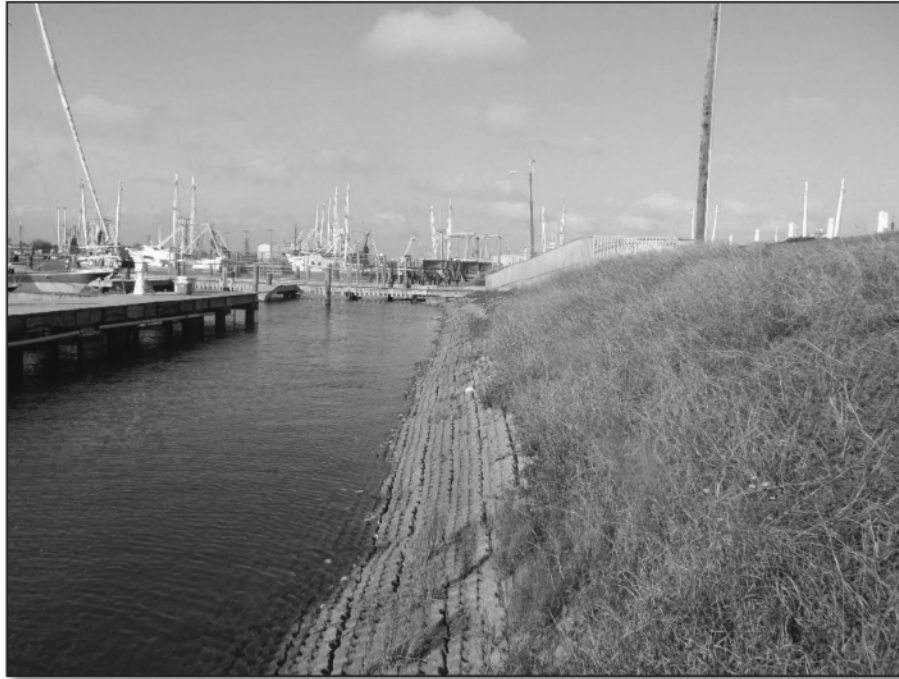
Photo 8-1 – ACM Typical Condition

- Based on the overall fair condition rating of the ACM, it is anticipated that the ACM has approximately 15 to 20 years of service life remaining. No widespread rehabilitation or repair measures are recommended at this time.

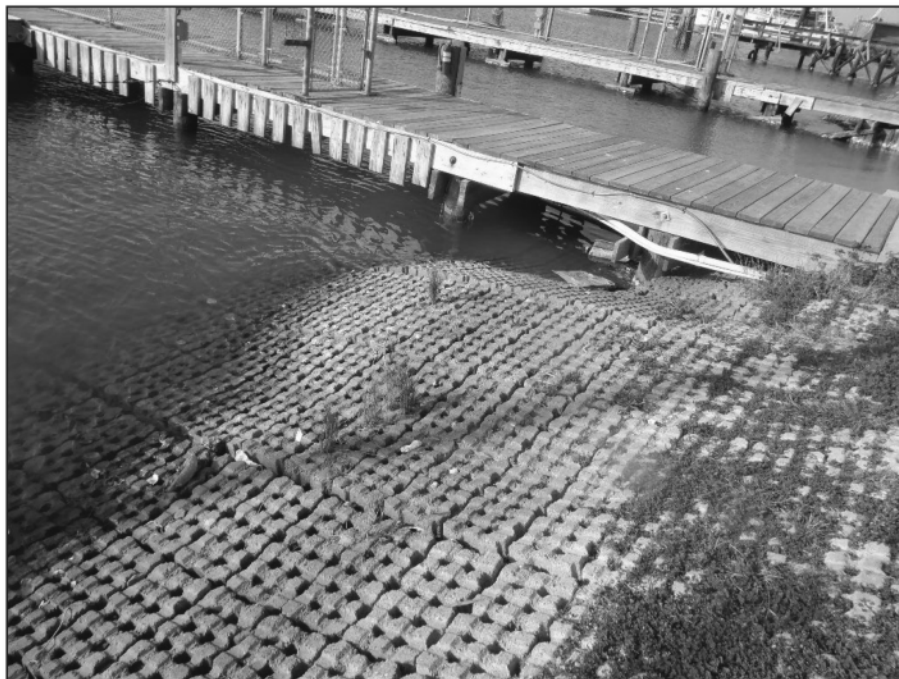
Photo 8-4 – ACM Typical Heaving
